Access Compliance Report
Public Rights-of-Way
(Curb Ramps)

Intersection ID: 28386	**Main Street:** MARVIN_RD	**Cross Street:** SOUTHAMPTON_COMMONS_DR	**Location:** N
ADA ID: FA970A42C80F	**Ramp Type:** Perp	**Initial Pass/Fail:** Fail **Overall Compliance:** No	**Severity Score:** 21.25

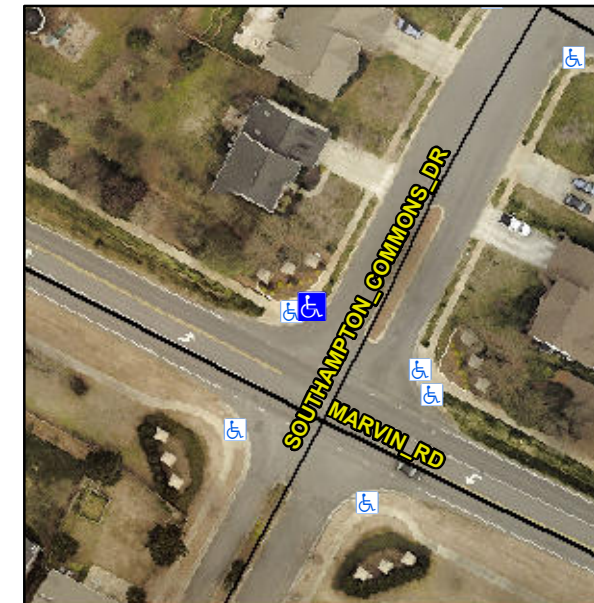
Not Found, R304.5.1, R304.2.2

Compliance	Description	Data	Compliance	Description	Data
N/A	Ramp Length (in)	60.0	No	Ramp Slope (%)	9.5
No	Ramp Width (in)	47.0	Yes	Ramp XSlope (%)	0.3
N/A	Flare Type LT	N/A	N/A	Flare Type RT	N/A
N/A	Flare Slope LT (%)	N/A	N/A	Flare Slope RT (%)	N/A
N/A	Flare Traversable LT?	N/A	N/A	Flare Traversable RT?	N/A
N/A	Landing Length (in)	N/A	N/A	DWS Provided?	N/A
N/A	Landing Width (in)	N/A	N/A	DWS Contrast?	N/A
N/A	Landing Slope (%)	N/A	N/A	DWS Length (in)	N/A
N/A	Landing X Slope (%)	N/A	N/A	DWS Full Width?	N/A
N/A	Landing Curb? (Y/N)	N/A	N/A	DWS Offset (in)	N/A
N/A	Shared Landing?	N/A			
N/A	Gutter Ponding?	N/A	N/A	Gutter Slope (%)	N/A
N/A	Gutter Lip Ht (in)	N/A	N/A	Gutter X Slope (%)	N/A
N/A	Painted X Walk1?	No	N/A	Painted X Walk2?	N/A
	X Walk 1 Direction	To SE		X Walk 2 Direction	N/A
N/A	X Walk 1 Width (in)	N/A	N/A	X Walk 2 Width (in)	N/A
	X Walk 1 Slope (%)	2.3		X Walk 2 Slope (%)	N/A
	X Walk 1 X Slope (%)	0.8		X Walk 2 X Slope (%)	N/A

Remove & Replace Entire Ramp.
