Access Compliance Report
Public Rights-of-Way
(Curb Ramps)

Intersection ID: N/A	Main Street: **REA_RD**	Cross Street: **FAIRWAYS_CLUB_DR**	Location:	**NW**
ADA ID: **FB0EB1E4AF29**	Ramp Type: **PerpDiag**	Initial Pass/Fail: **Fail**	Overall Compliance: **No**	Severity Score: **21.25**

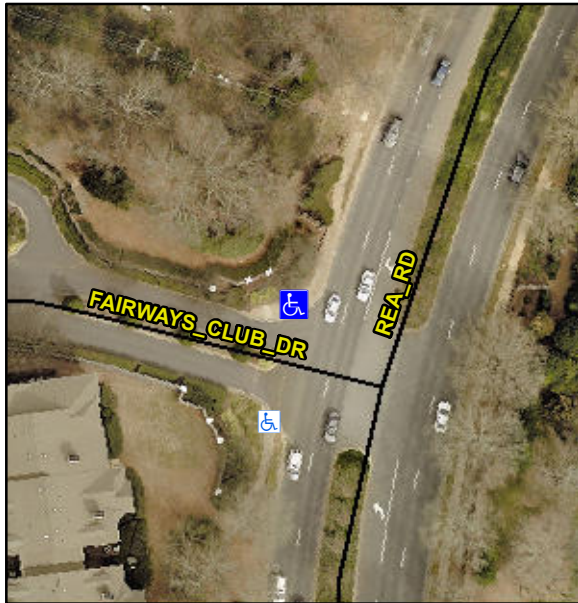
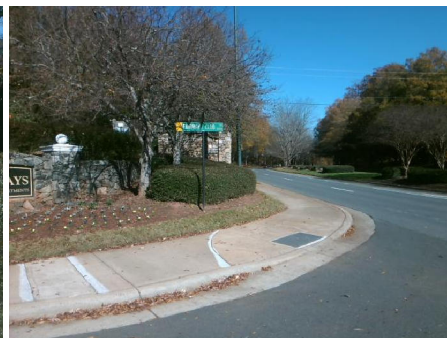
Not Found, R304.5.1, R304.2.2

Compliance	Description	Data	Compliance	Description	Data
N/A	Ramp Length (in)	87.0	No	Ramp Slope (%)	9.3
No	Ramp Width (in)	47.0	Yes	Ramp XSlope (%)	1.1
N/A	Flare Type LT	N/A	N/A	Flare Type RT	N/A
N/A	Flare Slope LT (%)	N/A	N/A	Flare Slope RT (%)	N/A
N/A	Flare Traversable LT?	N/A	N/A	Flare Traversable RT?	N/A
N/A	Landing Length (in)	N/A	N/A	DWS Provided?	N/A
N/A	Landing Width (in)	N/A	N/A	DWS Contrast?	N/A
N/A	Landing Slope (%)	N/A	N/A	DWS Length (in)	N/A
N/A	Landing X Slope (%)	N/A	N/A	DWS Full Width?	N/A
N/A	Landing Curb? (Y/N)	N/A	N/A	DWS Offset (in)	N/A
N/A	Shared Landing?	N/A			
N/A	Gutter Ponding?	N/A	N/A	Gutter Slope (%)	N/A
N/A	Gutter Lip Ht (in)	N/A	N/A	Gutter X Slope (%)	N/A
N/A	Painted X Walk1?	No	N/A	Painted X Walk2?	No
	X Walk 1 Direction	To S		X Walk 2 Direction	To E
N/A	X Walk 1 Width (in)	N/A	N/A	X Walk 2 Width (in)	N/A
	X Walk 1 Slope (%)	3.5		X Walk 2 Slope (%)	0.0
	X Walk 1 X Slope (%)	1.9		X Walk 2 X Slope (%)	5.3

**Remove & Replace Curb Ramp With Two New Directional Ramps or Equivalent.**
