Access Compliance Report

# Public Rights-of-Way
(Curb Ramps)

Intersection ID: 10038086	Main Street: SIKES_PL	Cross Street: N/A		Location:	SW
ADA ID: FB11AE45B7E5	Ramp Type: Perp	Initial Pass/Fail: Fail	Overall Compliance: No	Severity Score:	13.75

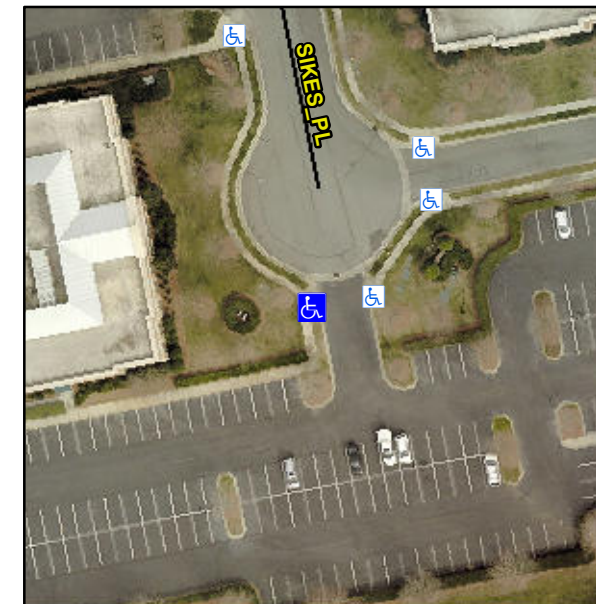
Not Found, R304.2.2, R304.5.3

Compliance	Description	Data	Compliance	Description	Data
N/A	Ramp Length (in)	62.0	No	Ramp Slope (%)	10.0
Yes	Ramp Width (in)	64.0	No	Ramp XSlope (%)	2.6
N/A	Flare Type LT	N/A	N/A	Flare Type RT	N/A
N/A	Flare Slope LT (%)	N/A	N/A	Flare Slope RT (%)	N/A
N/A	Flare Traversable LT?	N/A	N/A	Flare Traversable RT?	N/A
N/A	Landing Length (in)	N/A	N/A	DWS Provided?	N/A
N/A	Landing Width (in)	N/A	N/A	DWS Contrast?	N/A
N/A	Landing Slope (%)	N/A	N/A	DWS Length (in)	N/A
N/A	Landing X Slope (%)	N/A	N/A	DWS Full Width?	N/A
N/A	Landing Curb? (Y/N)	N/A	N/A	DWS Offset (in)	N/A
N/A	Shared Landing?	N/A			
N/A	Gutter Ponding?	N/A	N/A	Gutter Slope (%)	N/A
N/A	Gutter Lip Ht (in)	N/A	N/A	Gutter X Slope (%)	N/A
N/A	Painted X Walk1?	No	N/A	Painted X Walk2?	N/A
	X Walk 1 Direction	To E		X Walk 2 Direction	N/A
N/A	X Walk 1 Width (in)	N/A	N/A	X Walk 2 Width (in)	N/A
	X Walk 1 Slope (%)	1.5		X Walk 2 Slope (%)	N/A
	X Walk 1 X Slope (%)	1.2		X Walk 2 X Slope (%)	N/A

Remove & Replace Entire Ramp.
