Access Compliance Report
Public Rights-of-Way
(Curb Ramps)

Intersection ID: 2899	Main Street: RIDGE_RD	Cross Street: WAVERLY_LYNN_LN	Location:	NE
ADA ID: FB263ECBA5A7	Ramp Type: Perp	Initial Pass/Fail: Fail	Overall Compliance: No	Severity Score: 10

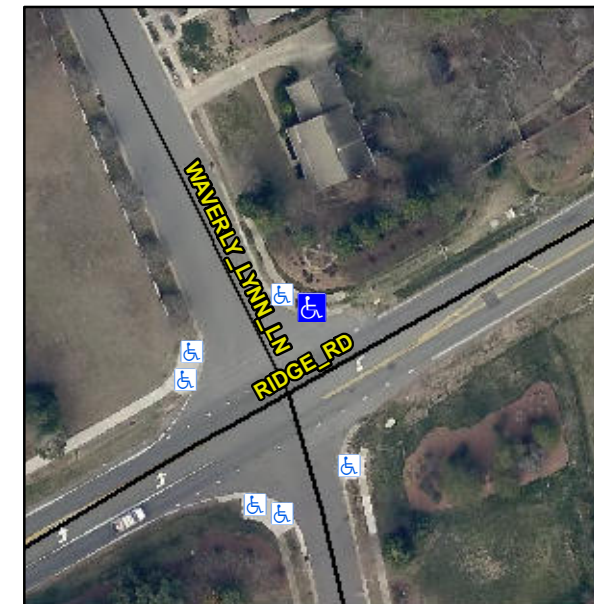
R304.5.1

Compliance	Description	Data	Compliance	Description	Data
N/A	Ramp Length (in)	96.0	Yes	Ramp Slope (%)	7.3
No	Ramp Width (in)	44.0	Yes	Ramp XSlope (%)	2.2
N/A	Flare Type LT	N/A	N/A	Flare Type RT	N/A
N/A	Flare Slope LT (%)	N/A	N/A	Flare Slope RT (%)	N/A
N/A	Flare Traversable LT?	N/A	N/A	Flare Traversable RT?	N/A
N/A	Landing Length (in)	N/A	N/A	DWS Provided?	N/A
N/A	Landing Width (in)	N/A	N/A	DWS Contrast?	N/A
N/A	Landing Slope (%)	N/A	N/A	DWS Length (in)	N/A
N/A	Landing X Slope (%)	N/A	N/A	DWS Full Width?	N/A
N/A	Landing Curb? (Y/N)	N/A	N/A	DWS Offset (in)	N/A
N/A	Shared Landing?	N/A			
N/A	Gutter Ponding?	N/A	N/A	Gutter Slope (%)	N/A
N/A	Gutter Lip Ht (in)	N/A	N/A	Gutter X Slope (%)	N/A
N/A	Painted X Walk1?	No	N/A	Painted X Walk2?	N/A
	X Walk 1 Direction	To S		X Walk 2 Direction	N/A
N/A	X Walk 1 Width (in)	N/A	N/A	X Walk 2 Width (in)	N/A
	X Walk 1 Slope (%)	3.7		X Walk 2 Slope (%)	N/A
	X Walk 1 X Slope (%)	3.3		X Walk 2 X Slope (%)	N/A

Remove & Replace Entire Ramp.
