Access Compliance Report
Public Rights-of-Way
(Curb Ramps)

Intersection ID: 53631	**Main Street:** PROVIDENCE_RD_WEST	**Cross Street:** BEACON_VALLEY_ST	**Location:** SE
ADA ID: FC26771B15AC	**Ramp Type:** Perp	**Initial Pass/Fail:** Fail	**Overall Compliance:** No **Severity Score:** 21.25

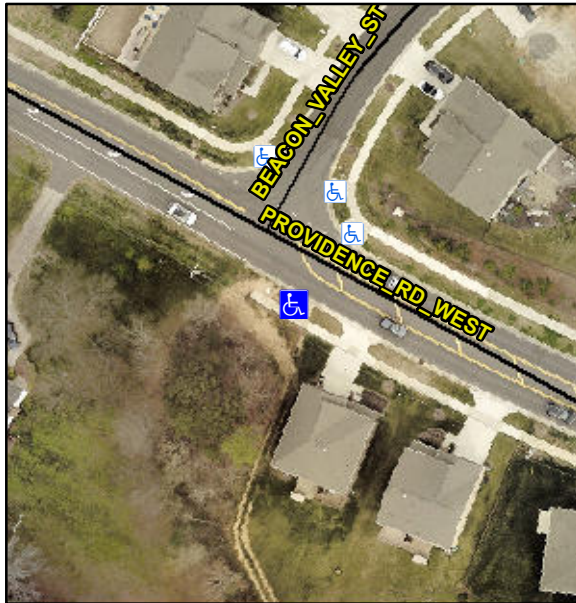
Not Found, R304.5.1, R304.2.2

Compliance	Description	Data	Compliance	Description	Data
N/A	Ramp Length (in)	97.0	No	Ramp Slope (%)	8.7
No	Ramp Width (in)	47.0	Yes	Ramp XSlope (%)	0.5
N/A	Flare Type LT	N/A	N/A	Flare Type RT	N/A
N/A	Flare Slope LT (%)	N/A	N/A	Flare Slope RT (%)	N/A
N/A	Flare Traversable LT?	N/A	N/A	Flare Traversable RT?	N/A
N/A	Landing Length (in)	N/A	N/A	DWS Provided?	N/A
N/A	Landing Width (in)	N/A	N/A	DWS Contrast?	N/A
N/A	Landing Slope (%)	N/A	N/A	DWS Length (in)	N/A
N/A	Landing X Slope (%)	N/A	N/A	DWS Full Width?	N/A
N/A	Landing Curb? (Y/N)	N/A	N/A	DWS Offset (in)	N/A
N/A	Shared Landing?	N/A			
N/A	Gutter Ponding?	N/A	N/A	Gutter Slope (%)	N/A
N/A	Gutter Lip Ht (in)	N/A	N/A	Gutter X Slope (%)	N/A
N/A	Painted X Walk1?	No	N/A	Painted X Walk2?	N/A
	X Walk 1 Direction	To NE		X Walk 2 Direction	N/A
N/A	X Walk 1 Width (in)	N/A	N/A	X Walk 2 Width (in)	N/A
	X Walk 1 Slope (%)	0.6		X Walk 2 Slope (%)	N/A
	X Walk 1 X Slope (%)	0.8		X Walk 2 X Slope (%)	N/A

Remove & Replace Entire Ramp.
