Access Compliance Report

# Public Rights-of-Way
(Curb Ramps)

Intersection ID: 14501	Main Street: BALDWIN_AV	Cross Street: ELLISON_ST	Location: W
ADA ID: FD2385798F65	Ramp Type: PerpDiag	Initial Pass/Fail: Fail	Overall Compliance: No	Severity Score: 25

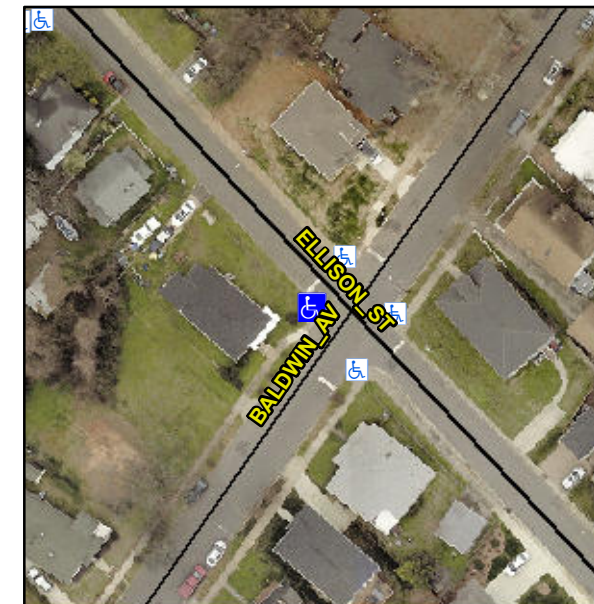
Not Found, R304.2.2

Compliance	Description	Data	Compliance	Description	Data
N/A	Ramp Length (in)	41.0	No	Ramp Slope (%)	14.6
Yes	Ramp Width (in)	48.0	Yes	Ramp XSlope (%)	0.5
N/A	Flare Type LT	N/A	N/A	Flare Type RT	N/A
N/A	Flare Slope LT (%)	N/A	N/A	Flare Slope RT (%)	N/A
N/A	Flare Traversable LT?	N/A	N/A	Flare Traversable RT?	N/A
N/A	Landing Length (in)	N/A	N/A	DWS Provided?	N/A
N/A	Landing Width (in)	N/A	N/A	DWS Contrast?	N/A
N/A	Landing Slope (%)	N/A	N/A	DWS Length (in)	N/A
N/A	Landing X Slope (%)	N/A	N/A	DWS Full Width?	N/A
N/A	Landing Curb? (Y/N)	N/A	N/A	DWS Offset (in)	N/A
N/A	Shared Landing?	N/A			
N/A	Gutter Ponding?	Yes	N/A	Gutter Slope (%)	N/A
N/A	Gutter Lip Ht (in)	N/A	N/A	Gutter X Slope (%)	N/A
N/A	Painted X Walk1?	No	N/A	Painted X Walk2?	No
	X Walk 1 Direction	To SE		X Walk 2 Direction	To NE
N/A	X Walk 1 Width (in)	N/A	N/A	X Walk 2 Width (in)	N/A
	X Walk 1 Slope (%)	1.1		X Walk 2 Slope (%)	3.0
	X Walk 1 X Slope (%)	3.2		X Walk 2 X Slope (%)	1.7

Remove & Replace Curb Ramp With Two New Directional Ramps or Equivalent.
