Access Compliance Report
Public Rights-of-Way
(Curb Ramps)

Intersection ID: 30125 **Main Street:** CLOONEY_LN **Cross Street:** RUMPLE_RD **Location:** N

ADA ID: FD4D84AB08F6 **Ramp Type:** Perp **Initial Pass/Fail:** Fail **Overall Compliance:** No **Severity Score:** 33.75

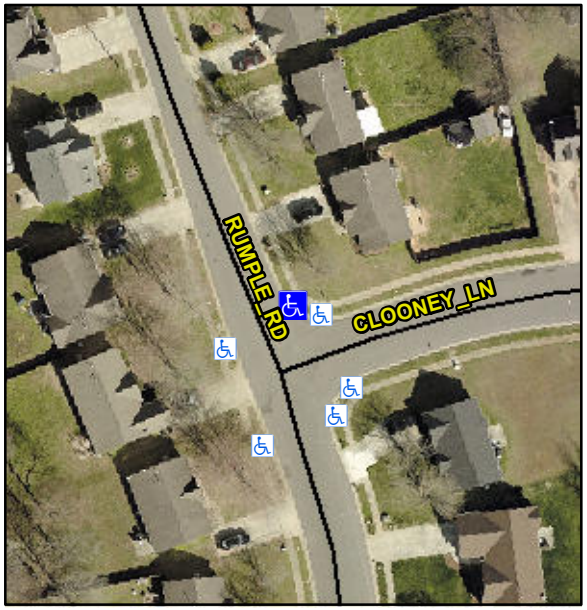
Not Found, R304.5.1, R304.5.3

Compliance	Description	Data	Compliance	Description	Data
N/A	Ramp Length (in)	50.0	Yes	Ramp Slope (%)	7.6
No	Ramp Width (in)	36.5	No	Ramp XSlope (%)	8.0
N/A	Flare Type LT	N/A	N/A	Flare Type RT	N/A
N/A	Flare Slope LT (%)	N/A	N/A	Flare Slope RT (%)	N/A
N/A	Flare Traversable LT?	N/A	N/A	Flare Traversable RT?	N/A
N/A	Landing Length (in)	N/A	N/A	DWS Provided?	N/A
N/A	Landing Width (in)	N/A	N/A	DWS Contrast?	N/A
N/A	Landing Slope (%)	N/A	N/A	DWS Length (in)	N/A
N/A	Landing X Slope (%)	N/A	N/A	DWS Full Width?	N/A
N/A	Landing Curb? (Y/N)	N/A	N/A	DWS Offset (in)	N/A
N/A	Shared Landing?	N/A			
N/A	Gutter Ponding?	N/A	N/A	Gutter Slope (%)	N/A
N/A	Gutter Lip Ht (in)	N/A	N/A	Gutter X Slope (%)	N/A
N/A	Painted X Walk1?	No	N/A	Painted X Walk2?	N/A
	X Walk 1 Direction	To W		X Walk 2 Direction	N/A
N/A	X Walk 1 Width (in)	N/A	N/A	X Walk 2 Width (in)	N/A
	X Walk 1 Slope (%)	3.3		X Walk 2 Slope (%)	N/A
	X Walk 1 X Slope (%)	2.5		X Walk 2 X Slope (%)	N/A

Remove & Replace Entire Ramp.
