# Access Compliance Report
Public Rights-of-Way
(Curb Ramps)

Intersection ID: 1002095	Main Street: J_W_CLAY_BV	Cross Street: N/A	Location: E
ADA ID: FD7340B86620	Ramp Type: Perp	Initial Pass/Fail: Fail	Overall Compliance: No	Severity Score: 35

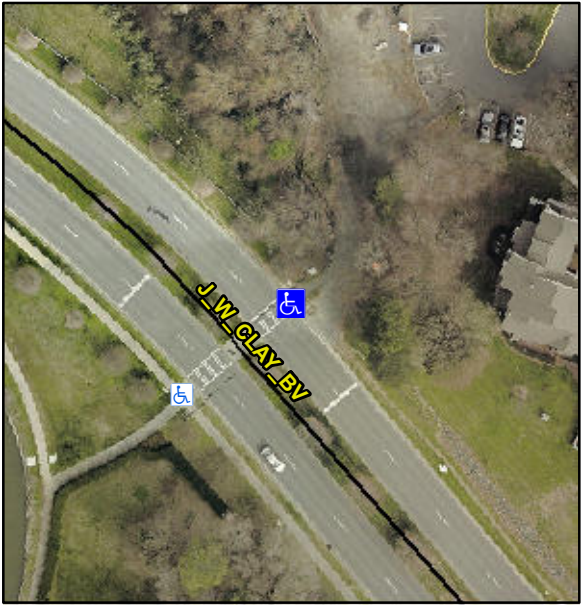
R304.5.1, R304.2.2, R304.5.3

Compliance	Description	Data	Compliance	Description	Data
N/A	Ramp Length (in)	30.0	No	Ramp Slope (%)	16.6
No	Ramp Width (in)	36.0	No	Ramp XSlope (%)	4.0
N/A	Flare Type LT	N/A	N/A	Flare Type RT	N/A
N/A	Flare Slope LT (%)	N/A	N/A	Flare Slope RT (%)	N/A
N/A	Flare Traversable LT?	N/A	N/A	Flare Traversable RT?	N/A
N/A	Landing Length (in)	N/A	N/A	DWS Provided?	N/A
N/A	Landing Width (in)	N/A	N/A	DWS Contrast?	N/A
N/A	Landing Slope (%)	N/A	N/A	DWS Length (in)	N/A
N/A	Landing X Slope (%)	N/A	N/A	DWS Full Width?	N/A
N/A	Landing Curb? (Y/N)	N/A	N/A	DWS Offset (in)	N/A
N/A	Shared Landing?	N/A			
N/A	Gutter Ponding?	N/A	N/A	Gutter Slope (%)	N/A
N/A	Gutter Lip Ht (in)	N/A	N/A	Gutter X Slope (%)	N/A
N/A	Painted X Walk1?	Yes	N/A	Painted X Walk2?	N/A
	X Walk 1 Direction	To W		X Walk 2 Direction	N/A
N/A	X Walk 1 Width (in)	110.0	N/A	X Walk 2 Width (in)	N/A
	X Walk 1 Slope (%)	2.8		X Walk 2 Slope (%)	N/A
	X Walk 1 X Slope (%)	3.2		X Walk 2 X Slope (%)	N/A

Remove & Replace Entire Ramp.
