# Access Compliance Report
## Public Rights-of-Way
## (Curb Ramps)

| **Intersection ID:** 26283 | **Main Street:** BEVINGTON_RIDGE_RD | **Cross Street:** BEVINGTON_WOODS_LN | **Location:** S |
| **ADA ID:** FE60A76473D2 | **Ramp Type:** BlendTrans1 | **Initial Pass/Fail:** Fail | **Overall Compliance:** No | **Severity Score:** 8.75 |

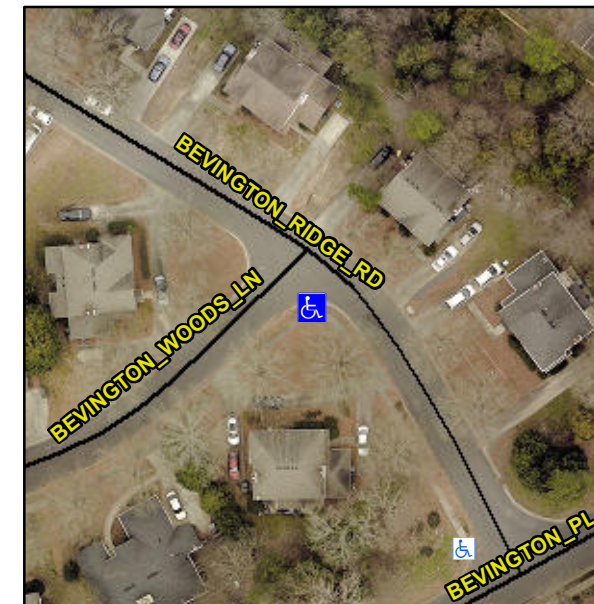
**Not Found, R304.5.1**

| Compliance | Description | Data | Compliance | Description | Data |
|---|---|---|---|---|---|
| No | Ramp Width (in) | 38.0 | Yes | BlendTrans XSlope (%) | 0.2 |
| | | | No | Curb Slope (%) | 17.8 |

**Remove & Replace Curb Ramp With Two New Directional Ramps or Equivalent.**
