Access Compliance Report
Public Rights-of-Way
(Curb Ramps)

Intersection ID: 15215	Main Street: HARRISBURG_RD	Cross Street: OLD_MEADOW_RD	Location:	SW
ADA ID: FEC56767B5AD	Ramp Type: PerpDiag	Initial Pass/Fail: Fail	Overall Compliance: No	Severity Score: 12.5

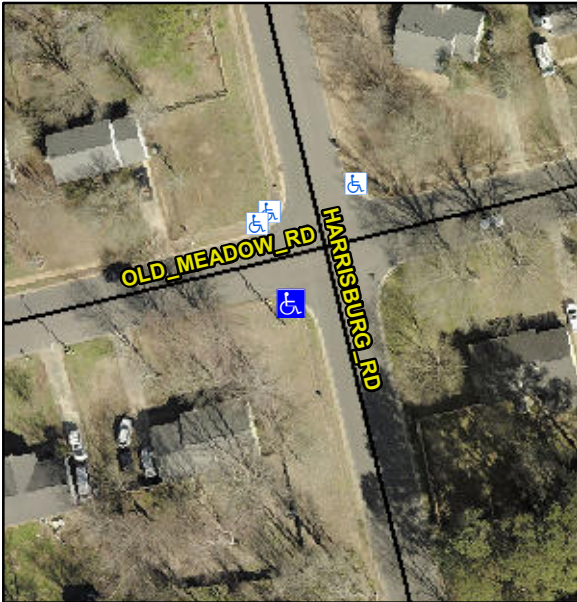
Compliance	Description	Data	Compliance	Description	Data
N/A	Ramp Length (in)	84.0	No	Ramp Slope (%)	8.8
Yes	Ramp Width (in)	48.0	Yes	Ramp XSlope (%)	1.7
N/A	Flare Type LT	N/A	N/A	Flare Type RT	N/A
N/A	Flare Slope LT (%)	N/A	N/A	Flare Slope RT (%)	N/A
N/A	Flare Traversable LT?	N/A	N/A	Flare Traversable RT?	N/A
N/A	Landing Length (in)	N/A	N/A	DWS Provided?	N/A
N/A	Landing Width (in)	N/A	N/A	DWS Contrast?	N/A
N/A	Landing Slope (%)	N/A	N/A	DWS Length (in)	N/A
N/A	Landing X Slope (%)	N/A	N/A	DWS Full Width?	N/A
N/A	Landing Curb? (Y/N)	N/A	N/A	DWS Offset (in)	N/A
N/A	Shared Landing?	N/A			
N/A	Gutter Ponding?	N/A	N/A	Gutter Slope (%)	N/A
N/A	Gutter Lip Ht (in)	N/A	N/A	Gutter X Slope (%)	N/A
N/A	Painted X Walk1?	No	N/A	Painted X Walk2?	No
	X Walk 1 Direction	To E		X Walk 2 Direction	To N
N/A	X Walk 1 Width (in)	N/A	N/A	X Walk 2 Width (in)	N/A
	X Walk 1 Slope (%)	4.3		X Walk 2 Slope (%)	4.8
	X Walk 1 X Slope (%)	4.2		X Walk 2 X Slope (%)	4.9

N/A	Ramp inside XWalk1?	N/A	N/A	Ramp inside XWalk2?	N/A
	Road Slope (%)	1.0	N/A	Clear Space?	N/A
	Road X Slope (%)	6.2	N/A	Clear Space to XWalk (in)	N/A
N/A	Any Obstructions?	N/A	N/A	Storm Grate/Utility Hazard?	N/A
	Obstruction Type			Storm Grate/Utility Type	
N/A					N/A
			Yes	Surface Condition? (G/P)	Good

Remove & Replace Curb Ramp With Two New Directional Ramps or Equivalent.
