Access Compliance Report
Public Rights-of-Way
(Curb Ramps)

Intersection ID: N/A | **Main Street:** YORK_CENTER | **Cross Street:** N/A | **Location:** NE

ADA ID: FF38DA379606 | **Ramp Type:** PerpDiag | **Initial Pass/Fail:** Fail | **Overall Compliance:** No | **Severity Score:** 33.75

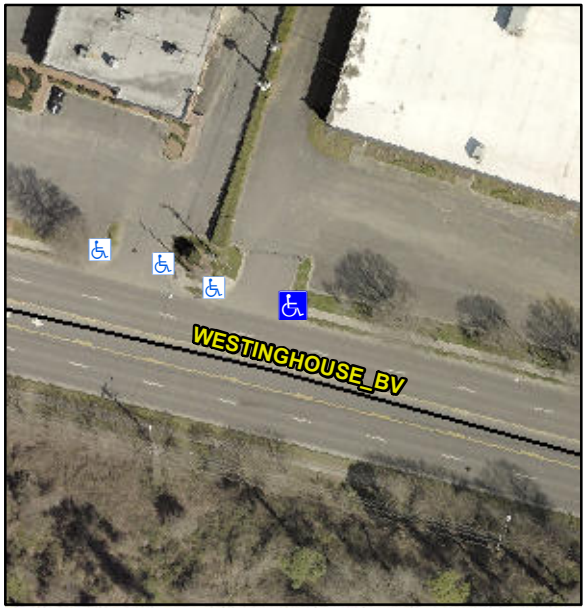
Not Found, R304.5.1, R304.5.3

Compliance	Description	Data	Compliance	Description	Data
N/A	Ramp Length (in)	82.0	Yes	Ramp Slope (%)	7.8
No	Ramp Width (in)	41.0	No	Ramp XSlope (%)	10.1
N/A	Flare Type LT	N/A	N/A	Flare Type RT	N/A
N/A	Flare Slope LT (%)	N/A	N/A	Flare Slope RT (%)	N/A
N/A	Flare Traversable LT?	N/A	N/A	Flare Traversable RT?	N/A
N/A	Landing Length (in)	N/A	N/A	DWS Provided?	N/A
N/A	Landing Width (in)	N/A	N/A	DWS Contrast?	N/A
N/A	Landing Slope (%)	N/A	N/A	DWS Length (in)	N/A
N/A	Landing X Slope (%)	N/A	N/A	DWS Full Width?	N/A
N/A	Landing Curb? (Y/N)	N/A	N/A	DWS Offset (in)	N/A
N/A	Shared Landing?	N/A			
N/A	Gutter Ponding?	N/A	N/A	Gutter Slope (%)	N/A
N/A	Gutter Lip Ht (in)	N/A	N/A	Gutter X Slope (%)	N/A
N/A	Painted X Walk1?	No	N/A	Painted X Walk2?	No
	X Walk 1 Direction	To NW		X Walk 2 Direction	To S
N/A	X Walk 1 Width (in)	N/A	N/A	X Walk 2 Width (in)	N/A
	X Walk 1 Slope (%)	1.2		X Walk 2 Slope (%)	3.7
	X Walk 1 X Slope (%)	5.3		X Walk 2 X Slope (%)	0.7

Remove & Replace Curb Ramp With Two New Directional Ramps or Equivalent.

Total Cost: **$ 3200.00**
