Access Compliance Report
Public Rights-of-Way
(Curb Ramps)

Intersection ID: 46179	**Main Street:** SEVEN_OAKS_DR	**Cross Street:** ROCKY_RIVER_RD	**Location:** SW
ADA ID: FF65A77572B0	**Ramp Type:** Directional1	**Initial Pass/Fail:** Pass **Overall Compliance:** No	**Severity Score:** 17.5

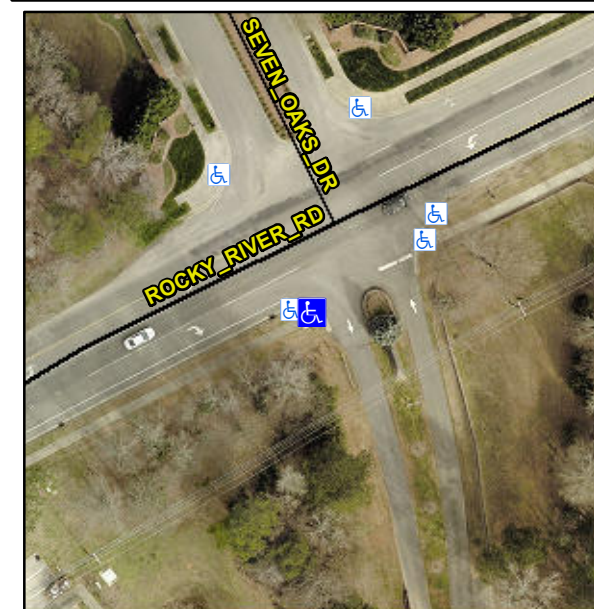
DWS NAILS EXPOSED, CURB LIP
1.0

Not Found, R304.5.3, R305, R302.7.2

Remove & Replace Entire Ramp.
Remove & Replace Gutter.
