Access Compliance Report
Public Rights-of-Way
(Curb Ramps)

Intersection ID: N/A | **Main Street:** WINSLET_DR | **Cross Street:** N/A | **Location:** SW

ADA ID: FF78C341EA33 | **Ramp Type:** Perp | **Initial Pass/Fail:** Fail | **Overall Compliance:** No | **Severity Score:** 26.25

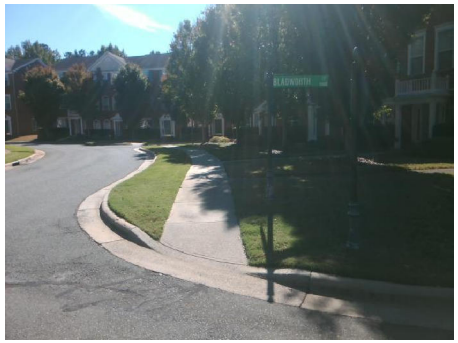
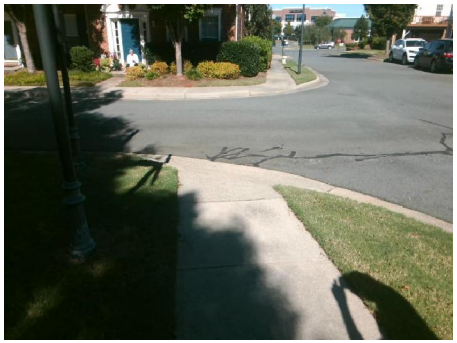
Not Found, R304.2.2, R304.5.3

Compliance	Description	Data	Compliance	Description	Data
N/A	Ramp Length (in)	25.0	No	Ramp Slope (%)	14.9
Yes	Ramp Width (in)	48.0	No	Ramp XSlope (%)	4.4
N/A	Flare Type LT	N/A	N/A	Flare Type RT	N/A
N/A	Flare Slope LT (%)	N/A	N/A	Flare Slope RT (%)	N/A
N/A	Flare Traversable LT?	N/A	N/A	Flare Traversable RT?	N/A
N/A	Landing Length (in)	N/A	N/A	DWS Provided?	N/A
N/A	Landing Width (in)	N/A	N/A	DWS Contrast?	N/A
N/A	Landing Slope (%)	N/A	N/A	DWS Length (in)	N/A
N/A	Landing X Slope (%)	N/A	N/A	DWS Full Width?	N/A
N/A	Landing Curb? (Y/N)	N/A	N/A	DWS Offset (in)	N/A
N/A	Shared Landing?	N/A			
N/A	Gutter Ponding?	N/A	N/A	Gutter Slope (%)	N/A
N/A	Gutter Lip Ht (in)	N/A	N/A	Gutter X Slope (%)	N/A
N/A	Painted X Walk1?	No	N/A	Painted X Walk2?	N/A
	X Walk 1 Direction	To N		X Walk 2 Direction	N/A
N/A	X Walk 1 Width (in)	N/A	N/A	X Walk 2 Width (in)	N/A
	X Walk 1 Slope (%)	0.3		X Walk 2 Slope (%)	N/A

Remove & Replace Entire Ramp.
