Access Compliance Report
Public Rights-of-Way
(Accessible Street Parking)

Intersection ID: N/A	**Main Street:** CLANTON RD	**Location:** N/A
ADA ID: 07C65C0A3AE2	**ParkingType:** ParaPark	**Overall Compliance:** No **Severity Score:** 0.0

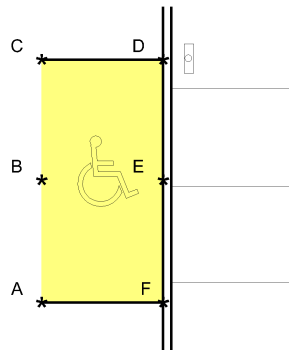
Compliance	Description	Data	Compliance	Description	Data
N/A	Parking Spot At End of Block?	No	Yes	Accessible Route?	Yes
Yes	Adjacent Sidewalk Width (in)	96.0	No	Access Aisle Marking?	Yes
No	Adjacent Sidewalk Slope (%)	2.6	No	Access Aisle Width (in)	57.0
Yes	Adjacent Sidewalk XSlope (%)	2.0	No	Access Aisle Length (in)	233.0
Yes	Adjacent Sidewalk Clear of Obstr.	Yes	N/A	Access Aisle Location	Side
			N/A	Parking Spot Width (in)	91.0
			N/A	Parking Spot Length (in)	261.0
			N/A	Van Accessible?	N/A
			Yes	Curb Ramp?	Yes
			N/A	Identification Sign?	N/A
			N/A	Sign Height (in)	N/A
			N/A	Vertical Clearance	N/A
			N/A	Parking Meter?	N/A
			N/A	Parking Meter Height (in)	N/A
			N/A	Meter Operable Parts?	N/A
			N/A	Meter Clear Space?	N/A
			N/A	Meter Clear Space Slope (%)	N/A
			N/A	Meter Clear Space XSlope (%)	N/A
			N/A	Meter Forward Reach?	N/A
			N/A	Meter Forward Reach (in)	N/A

C Slope (%)	1.3	D Slope (%)	2.6	I Slope (%)	N/A	L Slope (%)	N/A
B Slope (%)	2.4	E Slope (%)	1.4	H Slope (%)	N/A	K Slope (%)	N/A
A Slope (%)	2.9	F Slope (%)	2.4	G Slope (%)	N/A	J Slope (%)	N/A

C XSlope (%)	0.1	D XSlope (%)	1.1	I XSlope (%)	N/A	L XSlope (%)	N/A
B XSlope (%)	1.2	E XSlope (%)	2.7	H XSlope (%)	N/A	K XSlope (%)	N/A
A XSlope (%)	0.8	F XSlope (%)	1.0	G XSlope (%)	N/A	J XSlope (%)	N/A

Advise relocating to an area with maximum 2% slopes
