# Access Compliance Report

## Public Rights-of-Way

### (Curb Ramps)

| Intersection ID: 49130 | Main Street: AUBURN_HILL_LN | Cross Street: WILTSHIRE_RIDGE_RD | Location: SW |

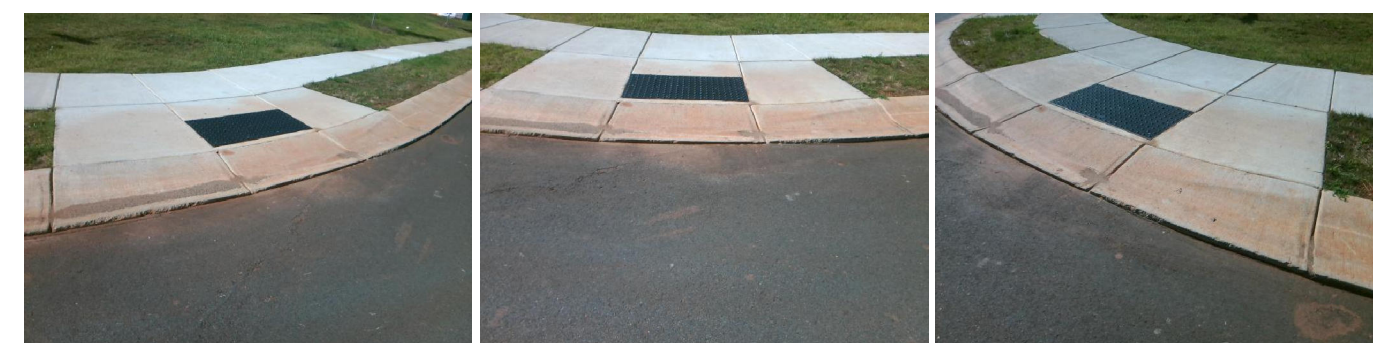
| ADA ID: 00576E8CD71B | Ramp Type: Perp | Initial Pass/Fail: Fail | Overall Compliance: No |

**Not Found, R304.5.1**

| Compliance | Description | Data | Compliance | Description | Data |
|---|---|---|---|---|---|
| No | Ramp Width (in) | 47.0 | Yes | Ramp XSlope (%) | 0.2 |

**Remove & Replace Entire Ramp.**
