Access Compliance Report

Public Rights-of-Way (Curb Ramps)

| Intersection ID: N/A | Main Street: MILLENNIUM_AV | Cross Street: CITY_PARK_DR | Location: SE |
| ADA ID: 005E35681147 | Ramp Type: Directional1 | Initial Pass/Fail: Fail | Overall Compliance: No |

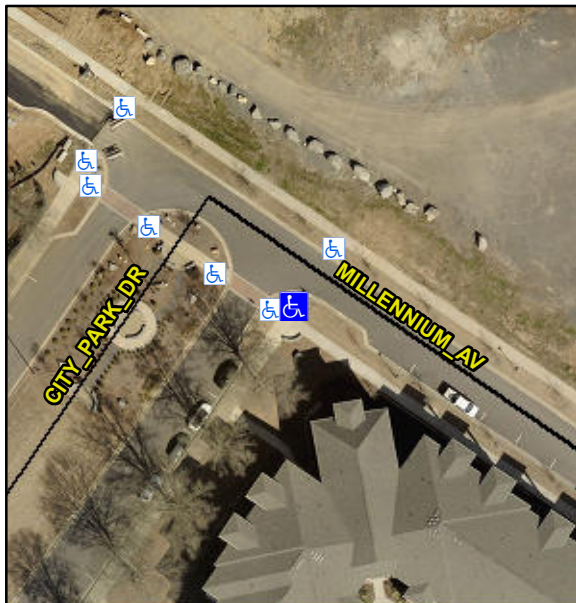
R304.5.3

| Compliance | Description | Data | Compliance | Description | Data |
|---|---|---|---|---|---|
| No | Ramp XSlope (%) | 4.9 | | | |

Remove & Replace Entire Ramp.
