# Access Compliance Report

## Public Rights-of-Way

### (Curb Ramps)

| Intersection ID: 12248 | Main Street: E_8TH_ST | Cross Street: N_BREVARD_ST | Location: W |

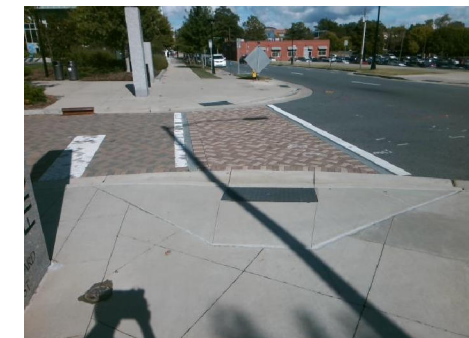
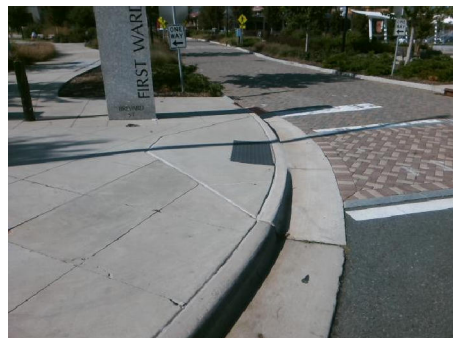
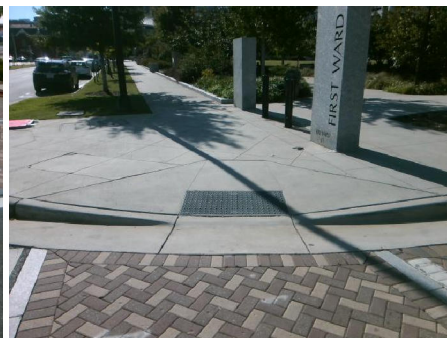
| ADA ID: 016353F220BB | Ramp Type: Perp | Initial Pass/Fail: Fail | Overall Compliance: No |

**Not Found, R304.5.1, R304.2.2**

| Compliance | Description | Data | Compliance | Description | Data |
|---|---|---|---|---|---|
| N/A | Ramp Length (in) | 72.0 | No | Ramp Slope (%) | 9.4 |
| No | Ramp Width (in) | 35.0 | Yes | Ramp XSlope (%) | 1.2 |

**Remove & Replace Entire Ramp.**
