# Access Compliance Report

## Public Rights-of-Way

| Intersection ID: 6039 | Main Street: DELLINGER_DR | Cross Street: MILHAVEN_LN | Location: NE |
| ADA ID: 017334E07DB7 | Ramp Type: PerpDiag | Initial Pass/Fail: Pass | Overall Compliance: No |

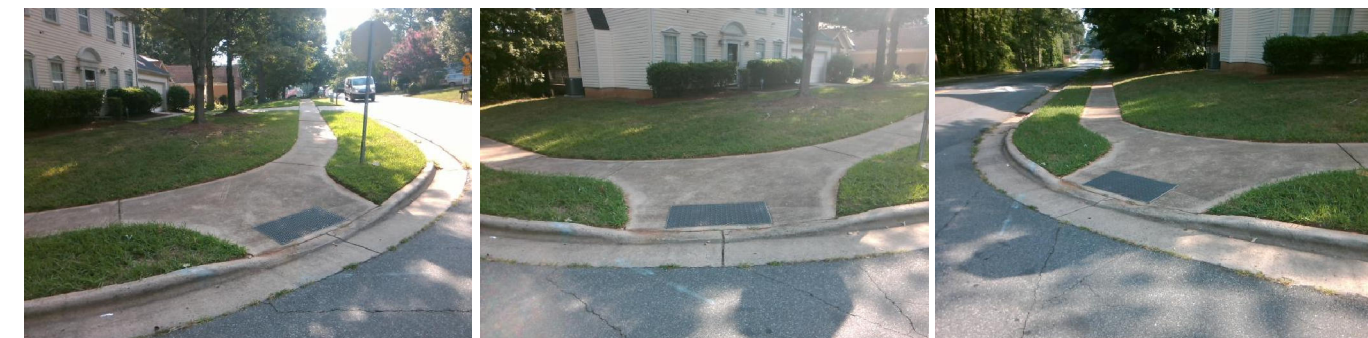
**Not Found, R304.5.3, R304.2.2-Perp, R304.3.2-Para, R305.2, R302.7.2, R304.5.4**

| Compliance | Description | Data | Compliance | Description | Data |
|---|---|---|---|---|---|
| Yes | Ramp Width (in) | 48.0 | No | Ramp XSlope (%) | 3.7 |
| No | Landing Slope (%) | 4.9 | Yes | DWS Length (in) | 24.0 |
| No | Landing X Slope (%) | 8.2 | Yes | DWS Full Width? | Yes |
| N/A | Landing Curb? (Y/N) | No | No | DWS Offset (in) | 4.5 |

**Remove & Replace Curb Ramp With Two New Directional Ramps or Equivalent. Remove & Replace Gutter.**
