# Access Compliance Report

## Public Rights-of-Way

### (Curb Ramps)

| Intersection ID: 50606 | Main Street: DENBUR_DR | Cross Street: BENDING_BRANCH_RD | Location: E |

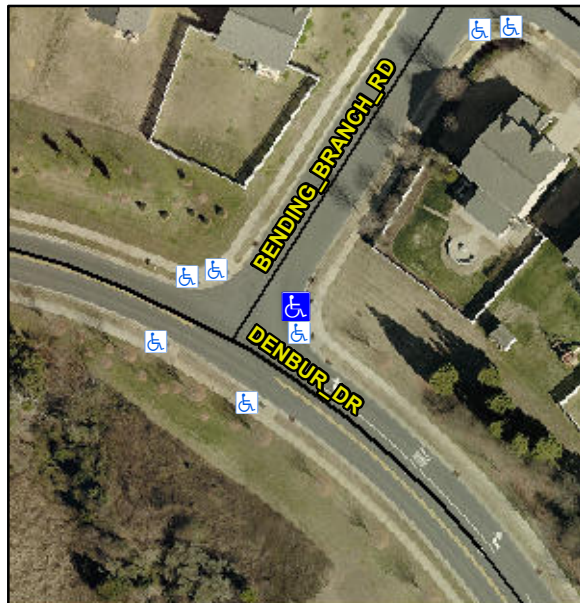
**Not Found, R304.5.1, R304.2.2, R304.5.3**

| Compliance | Description | Data | Compliance | Description | Data |
|---|---|---|---|---|---|
| N/A | Ramp Length (in) | 47.5 | No | Ramp Slope (%) | 9.3 |
| No | Ramp Width (in) | 41.0 | No | Ramp XSlope (%) | 5.2 |

**Remove & Replace Entire Ramp.**
