# Access Compliance Report

## Public Rights-of-Way

### (Curb Ramps)

| Intersection ID: 11217 | Main Street: ASHLEY_RD | Cross Street: BULLARD_ST | Location: S |

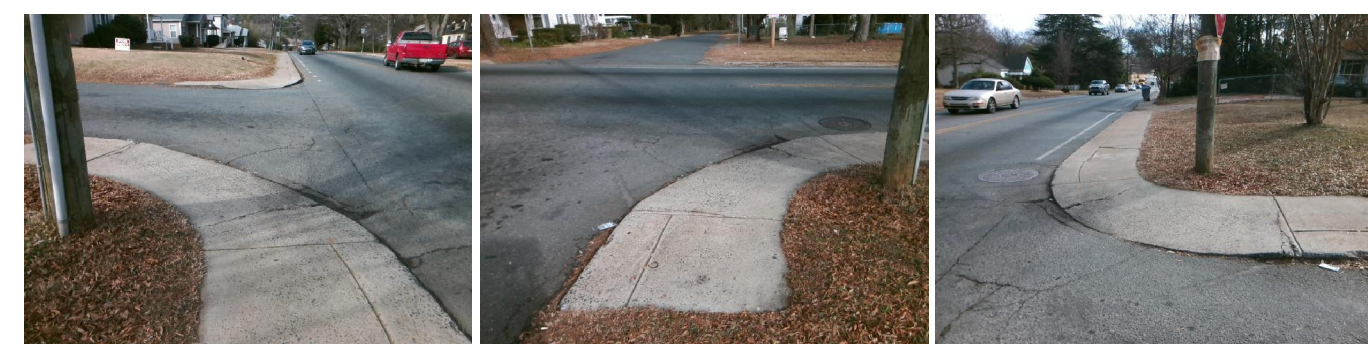
| ADA ID: 0484C547B409 | Ramp Type: Perp | Initial Pass/Fail: Fail | Overall Compliance: No |
| | | Severity Score: 37.5 | |

**R304.2.2, R304.5.3**

| Compliance | Description | Data | Compliance | Description | Data |
|---|---|---|---|---|---|
| N/A | Ramp Length (in) | 54.0 | No | Ramp Slope (%) | 12.2 |
| Yes | Ramp Width (in) | 48.0 | No | Ramp XSlope (%) | 5.9 |

**Remove & Replace Entire Ramp.**
