Access Compliance Report

Public Rights-of-Way

(Curb Ramps)

Intersection ID: 26966	Main Street: MISTY RIDGE LN	Cross Street: RIDGE HAVEN LN	Location: SE
ADA ID: 05D12C1198BF	Ramp Type: PerpDiag	Initial Pass/Fail: Fail	Overall Compliance: No
Severity Score: 37.5			
Codes/Mitigation Info/Possible Solution		Field Measurements/Component Compliance

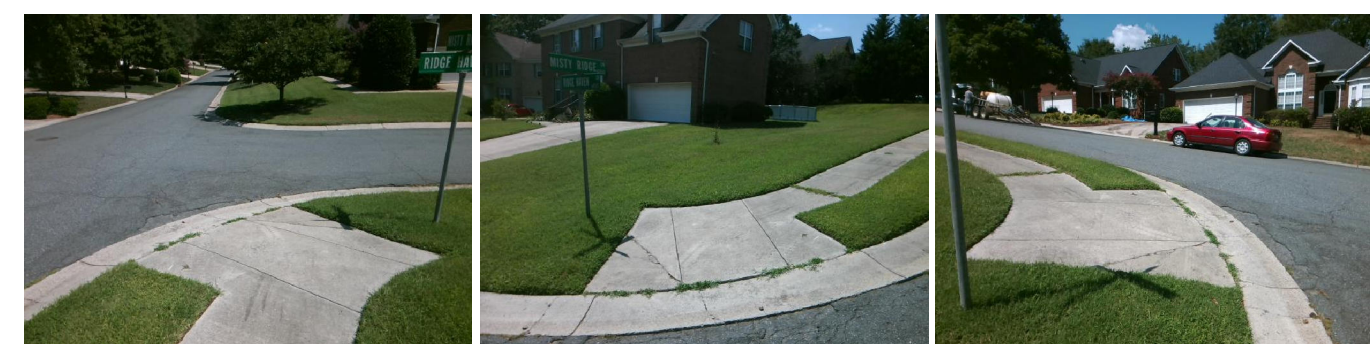
Not Found, R304.2.2, R304.5.3

Compliance	Description	Data	Compliance	Description	Data
N/A	Ramp Length (in)	95.0	No	Ramp Slope (%)	10.5
Yes	Ramp Width (in)	49.0	No	Ramp XSlope (%)	17.7
N/A	Flare Type LT	N/A	N/A	Flare Type RT	N/A
N/A	Flare Slope LT (%)	N/A	N/A	Flare Slope RT (%)	N/A
N/A	Flare Traversable LT?	N/A	N/A	Flare Traversable RT?	N/A
N/A	Landing Length (in)	N/A	N/A	DWS Provided?	N/A
N/A	Landing Width (in)	N/A	N/A	DWS Contrast?	N/A
N/A	Landing Slope (%)	N/A	N/A	DWS Length (in)	N/A
N/A	Landing X Slope (%)	N/A	N/A	DWS Full Width?	N/A
N/A	Landing Curb? (Y/N)	N/A	N/A	DWS Offset (in)	N/A
N/A	Shared Landing?	N/A			
N/A	Gutter Ponding?	N/A	N/A	Gutter Slope (%)	N/A
N/A	Gutter Lip Ht (in)	N/A	N/A	Gutter X Slope (%)	N/A
N/A	Painted X Walk1?	No	N/A	Painted X Walk2?	No
	X Walk 1 Direction	To NE		X Walk 2 Direction	To W
N/A	X Walk 1 Width (in)	N/A	N/A	X Walk 2 Width (in)	N/A
	X Walk 1 Slope (%)	8.7		X Walk 2 Slope (%)	7.4
	X Walk 1 X Slope (%)	8.2		X Walk 2 X Slope (%)	10.3

N/A	Ramp inside XWalk1?	N/A	N/A	Ramp inside XWalk2?	N/A
	Road Slope (%)	11.8	N/A	Clear Space?	N/A
	Road X Slope (%)	1.2	N/A	Clear Space to XWalk (in)	N/A
N/A	Any Obstructions?	N/A	N/A	Storm Grate/Utility Hazard?	N/A
	Obstruction Type			Storm Grate/Utility Type	
		N/A			N/A
			Yes	Surface Condition? (G/P)	Good

Remove & Replace Curb Ramp With Two New Directional Ramps or Equivalent.
