# Access Compliance Report

## Public Rights-of-Way

### (Curb Ramps)

Intersection ID: N/A	Main Street: EASTWYCKE_PLACE_DR	Cross Street: HICKORY_GROVE_RD	Location: NW
ADA ID: 05E2AE37C242	Ramp Type: Combination2Diag	Initial Pass/Fail: Fail	Overall Compliance: No
		Severity Score: 0

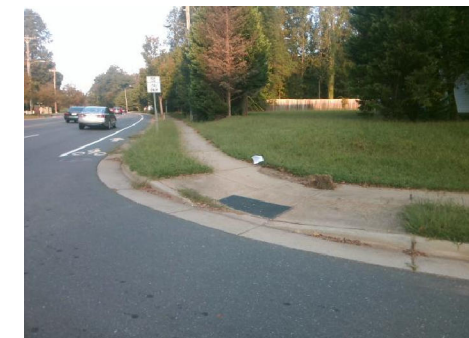
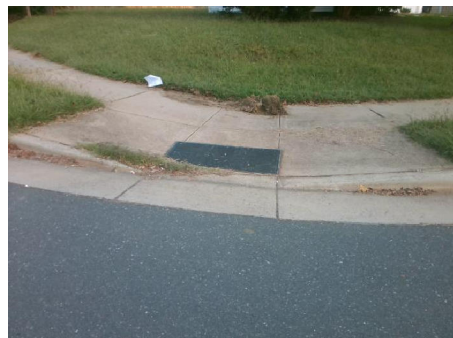
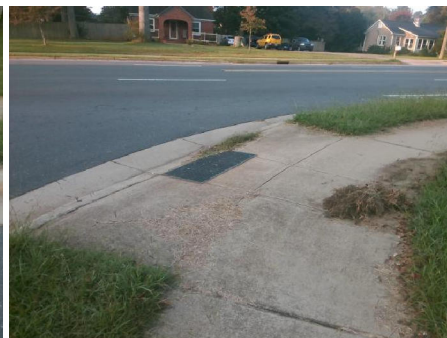
**Not Found, R304.5.1, R304.5.3, R304.3.2**

Compliance	Description	Data	Compliance	Description	Data
N/A	Ramp Length LT (in)	54.0	N/A	Ramp Length RT (in)	50.5
Yes	Ramp Width LT (in)	60.0	Yes	Ramp Width RT (in)	60.0
No	Ramp Slope LT (%)	8.7	Yes	Ramp Slope RT (%)	0.1
Yes	Ramp XSlope LT (%)	0.8	Yes	Ramp XSlope RT (%)	0.4
N/A	Ramp Length (in)	48.0	Yes	Ramp Slope (%)	7.1
No	Ramp Width (in)	40.5	No	Ramp XSlope (%)	2.9
N/A	Flare Type LT	N/A	N/A	Flare Type RT	N/A
N/A	Flare Slope LT (%)	N/A	N/A	Flare Slope RT (%)	N/A
N/A	Flare Traversable LT?	N/A	N/A	Flare Traversable RT?	N/A
N/A	Landing Length (in)	N/A	N/A	DWS Provided?	N/A
N/A	Landing Width (in)	N/A	N/A	DWS Contrast?	N/A
N/A	Landing Slope (%)	N/A	N/A	DWS Length (in)	N/A
N/A	Landing X Slope (%)	N/A	N/A	DWS Full Width?	N/A
N/A	Landing Curb? (Y/N)	N/A	N/A	DWS Offset (in)	N/A
N/A	Shared Landing?	N/A			
N/A	Gutter Ponding?	N/A	N/A	Gutter Slope (%)	N/A
N/A	Gutter Lip Ht (in)	N/A	N/A	Gutter X Slope (%)	N/A
N/A	Painted X Walk1?	No	N/A	Painted X Walk2?	No

X Walk 1 Direction	To S		X Walk 2 Direction	To E
	X Walk 1 Width (in)	N/A		X Walk 2 Width (in)	N/A
	X Walk 1 Slope (%)	0.1		X Walk 2 Slope (%)	3.7
	X Walk 1 X Slope (%)	2.9		X Walk 2 X Slope (%)	0.9
N/A	Ramp inside XWalk1?	N/A	N/A	Ramp inside XWalk2?	N/A
	Road Slope (%)	4.0		Clear Space?	N/A
	Road X Slope (%)	0.9	N/A	Clear Space to XWalk (in)	N/A
			N/A	Any Obstruction?	N/A
				Obstruction Type	N/A
			N/A	Storm Grate/Utility Hazard?	N/A
				Storm Grate/Utility Type	N/A
Yes	Surface Condition? (G/P)	Good			
	Curb Slope (%)	7.7

**Remove & Replace Curb Ramp With Two New Directional Ramps or Equivalent.**
