Access Compliance Report

Public Rights-of-Way

(Curb Ramps)

Intersection ID: 10790	Main Street: MARBETTA_LN	Cross Street: TIPPERARY_PL	Location: W
ADA ID: 07099B0A1F88	Ramp Type: Para	Initial Pass/Fail: Fail	Overall Compliance: No
Severity Score: 33.75			
Codes/Mitigation Info/Possible Solution		Field Measurements/Component Compliance

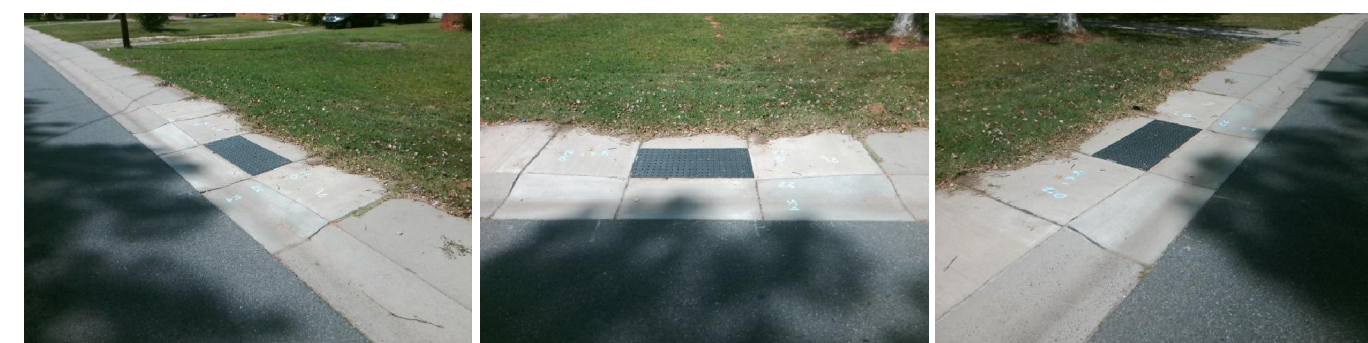
LT RP < 5%, RT RP < 5%

R304.5.1, R304.5.3

Compliance	Description	Data	Compliance	Description	Data
N/A	Ramp Length LT (in)	39.0	N/A	Ramp Length RT (in)	47.0
No	Ramp Width LT (in)	45.0	No	Ramp Width RT (in)	45.0
Yes	Ramp Slope LT (%)	3.8	Yes	Ramp Slope RT (%)	2.0
Yes	Ramp XSlope LT (%)	0.7	No	Ramp XSlope RT (%)	9.8
N/A	Landing Length (in)	N/A	N/A	DWS Provided?	N/A
N/A	Landing Width (in)	N/A	N/A	DWS Contrast?	N/A
N/A	Landing Slope (%)	N/A	N/A	DWS Length (in)	N/A
N/A	Landing X Slope (%)	N/A	N/A	DWS Full Width?	N/A
N/A	Landing Curb? (Y/N)	N/A	N/A	DWS Offset (in)	N/A
N/A	Shared Landing?	N/A			
N/A	Gutter Ponding?	N/A	N/A	Gutter Slope (%)	N/A
N/A	Gutter Lip Ht (in)	N/A	N/A	Gutter X Slope (%)	N/A
N/A	Painted X Walk1?	No	N/A	Painted X Walk2?	N/A
	X Walk 1 Direction	To S		X Walk 2 Direction	N/A
N/A	X Walk 1 Width (in)	N/A	N/A	X Walk 2 Width (in)	N/A
	X Walk 1 Slope (%)	5.9		X Walk 2 Slope (%)	N/A
	X Walk 1 X Slope (%)	2.6		X Walk 2 X Slope (%)	N/A
N/A	Ramp inside XWalk1?	N/A	N/A	Ramp inside XWalk2?	N/A

Road Slope (%)	N/A	N/A	Clear Space?	N/A
	Road X Slope (%)	N/A	N/A	Clear Space to XWalk (in)	N/A
N/A	Any Obstructions?	N/A	N/A	Storm Grate/Utility Hazard?	N/A
	Obstruction Type			Storm Grate/Utility Type	
		N/A			N/A
			Yes	Surface Condition? (G/P)	Good
			Compliant	Curb Slope (%)	5.8

Remove & Replace Entire Ramp.
