# Access Compliance Report

## Public Rights-of-Way

### (Curb Ramps)

Intersection ID: 5598	Main Street: MALLARD_CREEK_RD	Cross Street: MALLARD_PARK_DR	Location: W
ADA ID: 08414E32E16B	Ramp Type: Combination2	Initial Pass/Fail: Fail	Overall Compliance: No
			Severity Score: 13.75

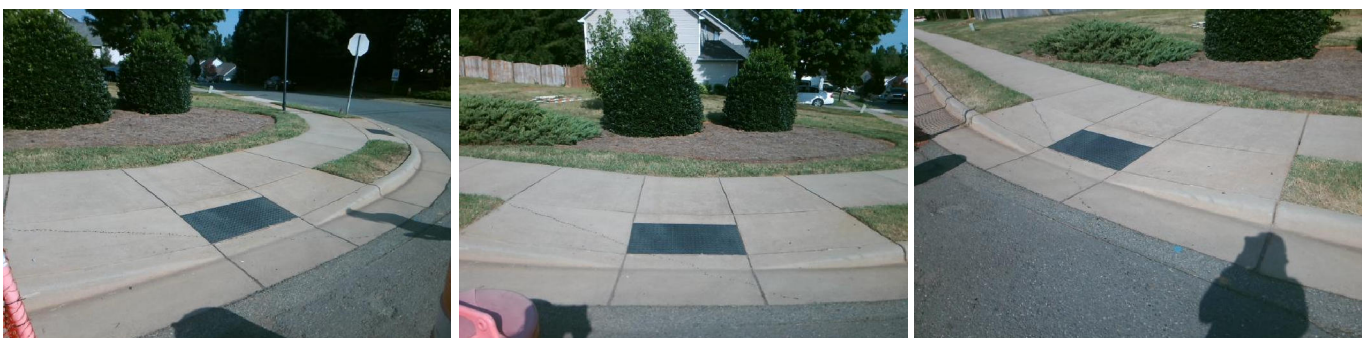
Possible Solutions:		<b>Compliance</b>	<b>Description</b>	<b>Data</b>
	Remove & Replace Entire Ramp.		N/A	Ramp Length LT (in)	53.5
			Yes	Ramp Width LT (in)	59.5
			No	Ramp Slope LT (%)	8.4
			No	Ramp XSlope LT (%)	2.7
			N/A	Ramp Length (in)	36.0
			Yes	Ramp Width (in)	48.0
	Surveyor Notes:		N/A	Flare Type LT	N/A
	N/A		N/A	Flare Slope LT (%)	N/A
			N/A	Flare Traversable LT?	N/A
<p>PROW/ADA:</p> <p><b>Not Found, R304.2.2, R304.5.3, R304.3.2</b></p>			N/A	Landing Length (in)	N/A
			N/A	Landing Width (in)	N/A
			N/A	Landing Slope (%)	N/A
			N/A	Landing X Slope (%)	N/A
			N/A	Landing Curb? (Y/N)	N/A
			N/A	Shared Landing?	N/A
			N/A	Gutter Ponding?	N/A
			N/A	Gutter Lip Ht (in)	N/A
			N/A	Painted X Walk1?	No
				X Walk 1 Direction	To SE
<p>Total Cost: \$ 1600.00</p>			N/A	X Walk 1 Width (in)	N/A
				X Walk 1 Slope (%)	5.8
				X Walk 1 X Slope (%)	2.5
