Access Compliance Report

Public Rights-of-Way

(Curb Ramps)

Intersection ID: 26766	Main Street: SETON_HOUSE_LN	Cross Street: N/A	Location: SW
ADA ID: 0927D3DDD340	Ramp Type: Perp	Initial Pass/Fail: Fail	Overall Compliance: No
Severity Score: 8.75			
Codes/Mitigation Info/Possible Solution		Field Measurements/Component Compliance

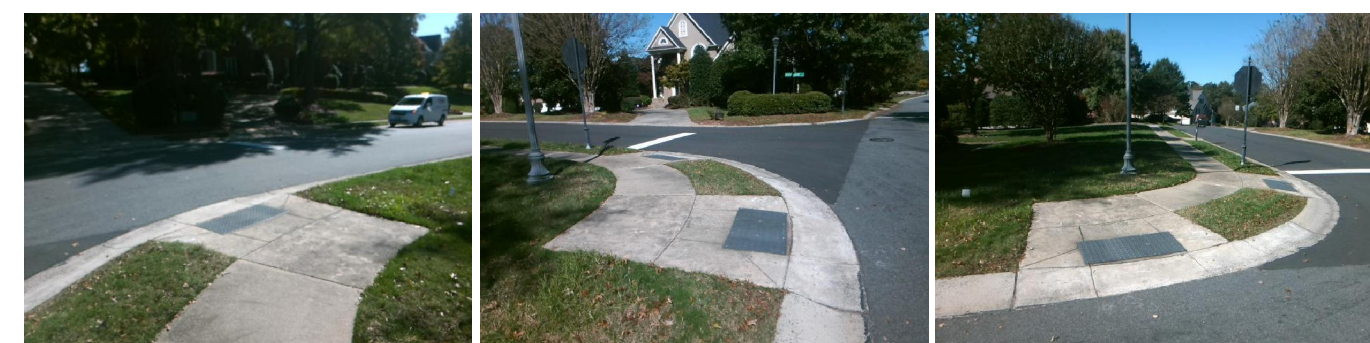
Not Found, R304.5.1

Compliance	Description	Data	Compliance	Description	Data
N/A	Ramp Length (in)	47.5	Yes	Ramp Slope (%)	7.1
No	Ramp Width (in)	36.5	Yes	Ramp XSlope (%)	0.3
N/A	Flare Type LT	N/A	N/A	Flare Type RT	N/A
N/A	Flare Slope LT (%)	N/A	N/A	Flare Slope RT (%)	N/A
N/A	Flare Traversable LT?	N/A	N/A	Flare Traversable RT?	N/A
N/A	Landing Length (in)	N/A	N/A	DWS Provided?	N/A
N/A	Landing Width (in)	N/A	N/A	DWS Contrast?	N/A
N/A	Landing Slope (%)	N/A	N/A	DWS Length (in)	N/A
N/A	Landing X Slope (%)	N/A	N/A	DWS Full Width?	N/A
N/A	Landing Curb? (Y/N)	N/A	N/A	DWS Offset (in)	N/A
N/A	Shared Landing?	N/A			
N/A	Gutter Ponding?	N/A	N/A	Gutter Slope (%)	N/A
N/A	Gutter Lip Ht (in)	N/A	N/A	Gutter X Slope (%)	N/A
N/A	Painted X Walk1?	No	N/A	Painted X Walk2?	N/A
	X Walk 1 Direction	To E		X Walk 2 Direction	N/A
N/A	X Walk 1 Width (in)	N/A	N/A	X Walk 2 Width (in)	N/A
	X Walk 1 Slope (%)	3.1		X Walk 2 Slope (%)	N/A
	X Walk 1 X Slope (%)	1.4		X Walk 2 X Slope (%)	N/A

Remove & Replace Entire Ramp.
