# Access Compliance Report

## Public Rights-of-Way

### (Curb Ramps)

Intersection ID: 10541	Main Street: CANTON_PL	Cross Street: POLK_ST	Location: E
ADA ID: 099EB249DDAB	Ramp Type: Perp	Initial Pass/Fail: Fail	Overall Compliance: No
			Severity Score: 21.25

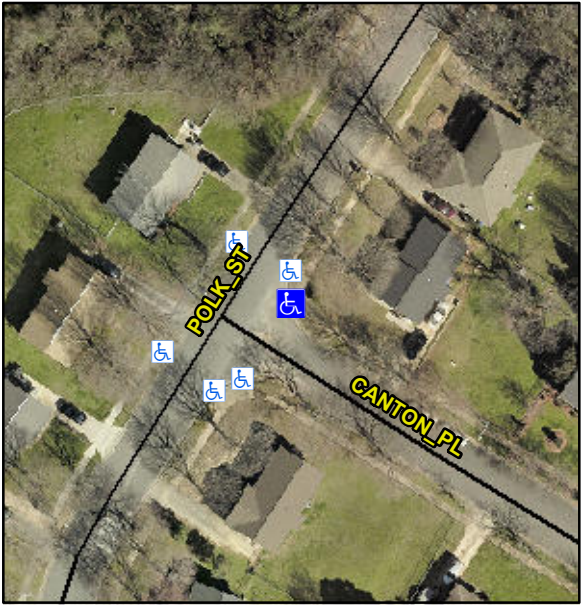
Possible Solutions:		<b>Compliance</b>	<b>Description</b>	<b>Data</b>
	<b>Remove &amp; Replace Entire Ramp.</b>		<b>No</b>	Ramp Length (in)	80.5
			<b>No</b>	Ramp Width (in)	47.0
			<b>N/A</b>	Flare Type LT	N/A
			<b>N/A</b>	Flare Slope LT (%)	N/A
			<b>N/A</b>	Flare Traversable LT?	N/A
			<b>N/A</b>	Landing Length (in)	N/A
			<b>N/A</b>	Landing Width (in)	N/A
			<b>N/A</b>	Landing Slope (%)	N/A
			<b>N/A</b>	Landing X Slope (%)	N/A
<p>Surveyor Notes:</p> <p><b>N/A</b></p> <p>PROW/ADA:</p> <p><b>Not Found, R304.5.1, R304.2.2</b></p>			<b>N/A</b>	Flare Type RT	N/A
			<b>N/A</b>	Flare Slope RT (%)	N/A
			<b>N/A</b>	Flare Traversable RT?	N/A
			<b>N/A</b>	DWS Provided?	N/A
			<b>N/A</b>	DWS Contrast?	N/A
			<b>N/A</b>	DWS Length (in)	N/A
			<b>N/A</b>	DWS Full Width?	N/A
			<b>N/A</b>	DWS Offset (in)	N/A
			<b>N/A</b>	Gutter Ponding?	N/A

<b>N/A</b>	Gutter Lip Ht (in)	0.5
			<b>No</b>	Painted X Walk1?	N/A
				X Walk 1 Direction	To SW
			<b>N/A</b>	X Walk 1 Width (in)	N/A
				X Walk 1 Slope (%)	2.1
				X Walk 1 X Slope (%)	1.3
			<b>N/A</b>	Ramp inside XWalk1?	N/A
			<b>N/A</b>	Road Slope (%)	N/A
			<b>N/A</b>	Road X Slope (%)	N/A
			<b>N/A</b>	Any Obstructions?	N/A
				Obstruction Type	
Total Cost: \$ 1850.00			<b>N/A</b>	Storm Grate/Utility Hazard?	N/A
				Storm Grate/Utility Type	
			<b>N/A</b>		N/A
			<b>Yes</b>	Surface Condition? (G/P)	Good
