# Access Compliance Report

## Public Rights-of-Way

### (Curb Ramps)

| Intersection ID: 9678 | Main Street: THE_PLAZA | Cross Street: VANDERBROOK_RD | Location: S |

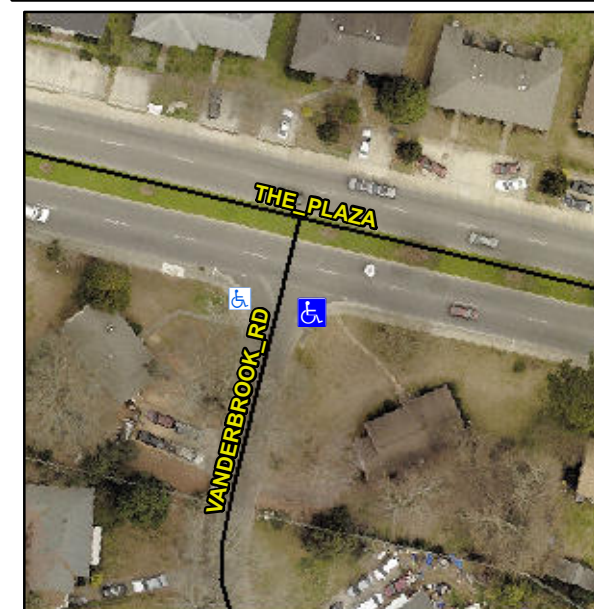
| ADA ID: 0C0F63C06DA8 | Ramp Type: Perp | Initial Pass/Fail: Fail | Overall Compliance: No |

**Not Found, R304.5.1, R304.5.3**

| Compliance | Description | Data | Compliance | Description | Data |
|---|---|---|---|---|---|
| N/A | Ramp Length (in) | 56.5 | Yes | Ramp Slope (%) | 7.0 |
| No | Ramp Width (in) | 47.0 | No | Ramp XSlope (%) | 4.2 |

**Remove & Replace Entire Ramp.**
