Access Compliance Report

Public Rights-of-Way

(Curb Ramps)

Intersection ID: 5093	Main Street: KELVIN_PARK_CR	Cross Street: PENNYCROSS_LN	Location: SW
ADA ID: 0D99DF2D0820	Ramp Type: Combination1	Initial Pass/Fail: Fail	Overall Compliance: No
			Severity Score: 46.25

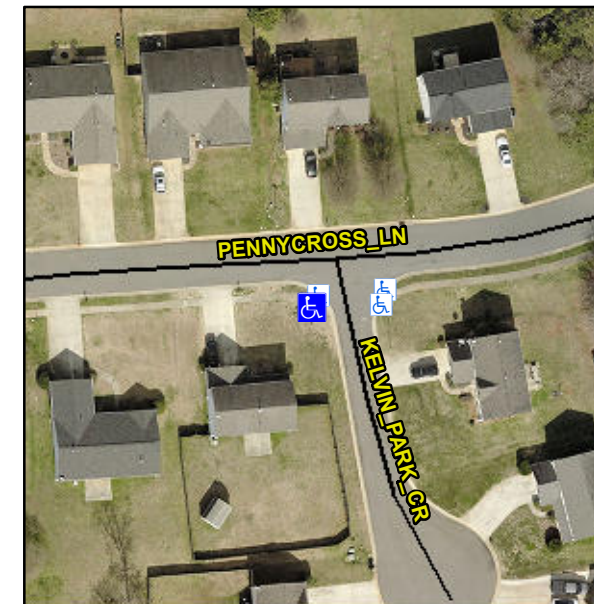
NO LT SW

**Not Found, R304.5.1, R304.5.1,
R304.2.2, R304.5.3, R304.3.2**

Compliance	Description	Data	Compliance	Description	Data
N/A	Ramp Length LT (in)	46.0	N/A	Ramp Length RT (in)	60.0
No	Ramp Width LT (in)	47.0	Yes	Ramp Width RT (in)	48.0
Yes	Ramp Slope LT (%)	5.1	No	Ramp Slope RT (%)	9.2
No	Ramp XSlope LT (%)	6.2	Yes	Ramp XSlope RT (%)	1.4
N/A	Ramp Length (in)	69.0	No	Ramp Slope (%)	10.8
No	Ramp Width (in)	37.0	No	Ramp XSlope (%)	10.7
N/A	Flare Type LT	N/A	N/A	Flare Type RT	N/A
N/A	Flare Slope LT (%)	N/A	N/A	Flare Slope RT (%)	N/A
N/A	Flare Traversable LT?	N/A	N/A	Flare Traversable RT?	N/A
N/A	Landing Length (in)	N/A	N/A	DWS Provided?	N/A
N/A	Landing Width (in)	N/A	N/A	DWS Contrast?	N/A
N/A	Landing Slope (%)	N/A	N/A	DWS Length (in)	N/A
N/A	Landing X Slope (%)	N/A	N/A	DWS Full Width?	N/A
N/A	Landing Curb? (Y/N)	N/A	N/A	DWS Offset (in)	N/A
N/A	Shared Landing?	N/A			
N/A	Gutter Ponding?	N/A	N/A	Gutter Slope (%)	N/A
N/A	Gutter Lip Ht (in)	N/A	N/A	Gutter X Slope (%)	N/A
N/A	Painted X Walk1?	No	N/A	Painted X Walk2?	N/A

X Walk 1 Direction	To E		X Walk 2 Direction	N/A
	X Walk 1 Width (in)	N/A		X Walk 2 Width (in)	N/A
	X Walk 1 Slope (%)	1.7		X Walk 2 Slope (%)	N/A
	X Walk 1 X Slope (%)	7.7		X Walk 2 X Slope (%)	N/A
N/A	Ramp inside XWalk1?	N/A	N/A	Ramp inside XWalk2?	N/A
	Road Slope (%)	N/A		Clear Space?	N/A
	Road X Slope (%)	N/A	N/A	Clear Space to XWalk (in)	N/A
			N/A	Any Obstruction?	N/A
				Obstruction Type	N/A
			N/A	Storm Grate/Utility Hazard?	N/A
				Storm Grate/Utility Type	N/A
			Yes	Surface Condition? (G/P)	Good
				Curb Slope (%)	13.0

Remove & Replace Entire Ramp.
