# Access Compliance Report

## Public Rights-of-Way

### (Curb Ramps)

Intersection ID: 6073	Main Street: SUTHER_RD	Cross Street: VINCA_CR	Location:	N
ADA ID: 0DAE69411D23	Ramp Type: Perp	Initial Pass/Fail: Fail	Overall Compliance: No	Severity Score: 50

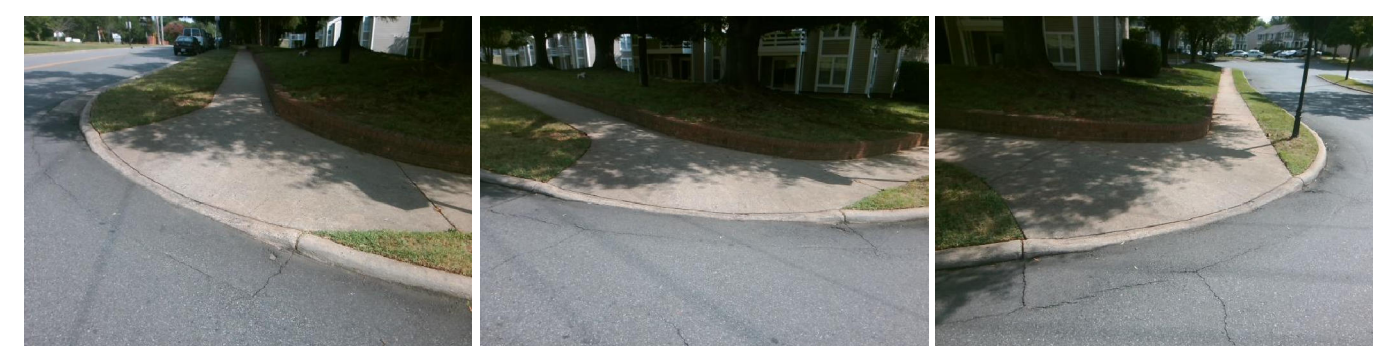
<div>Street 1 NameVINCA CR</div> <div>Stop Condition-Street 2StopSign</div> <div>Street 2 NameN/A</div> <div>Stop Condition-Street 1N/A</div>	Possible Solutions:		Compliance			Compliance		
	Remove & Replace Entire Ramp.		N/A	Ramp Length (in)	52.0	No	Ramp Slope (%)	13.8
			Yes	Ramp Width (in)	48.0	No	Ramp XSlope (%)	8.0
			N/A	Flare Type LT	N/A	N/A	Flare Type RT	N/A
			N/A	Flare Slope LT (%)	N/A	N/A	Flare Slope RT (%)	N/A
			N/A	Flare Traversable LT?	N/A	N/A	Flare Traversable RT?	N/A
			N/A	Landing Length (in)	N/A	N/A	DWS Provided?	N/A
			N/A	Landing Width (in)	N/A	N/A	DWS Contrast?	N/A
			N/A	Landing Slope (%)	N/A	N/A	DWS Length (in)	N/A
			N/A	Landing X Slope (%)	N/A	N/A	DWS Full Width?	N/A
Surveyor Notes:		N/A	N/A	Landing Curb? (Y/N)	N/A	N/A	DWS Offset (in)	N/A
PROW/ADA:		Not Found, R304.2.2, R304.5.3	N/A	Shared Landing?	N/A

N/A	Gutter Ponding?	N/A	N/A	Gutter Slope (%)	N/A
			N/A	Gutter Lip Ht (in)	N/A	N/A	Gutter X Slope (%)	N/A
			N/A	Painted X Walk1?	No	N/A	Painted X Walk2?	N/A
				X Walk 1 Direction	To SE		X Walk 2 Direction	N/A
			N/A	X Walk 1 Width (in)	N/A	N/A	X Walk 2 Width (in)	N/A
				X Walk 1 Slope (%)	0.8		X Walk 2 Slope (%)	N/A
				X Walk 1 X Slope (%)	8.5		X Walk 2 X Slope (%)	N/A
			N/A	Ramp inside XWalk1?	N/A	N/A	Ramp inside XWalk2?	N/A
				Road Slope (%)	N/A	N/A	Clear Space?	N/A
				Road X Slope (%)	N/A	N/A	Clear Space to XWalk (in)	N/A
			N/A	Any Obstructions?	N/A	N/A	Storm Grate/Utility Hazard?	N/A
				Obstruction Type			Storm Grate/Utility Type	
					N/A			N/A
						Yes	Surface Condition? (G/P)	Good
Total Cost:		\$ 1850.00
