Access Compliance Report

Public Rights-of-Way

(Curb Ramps)

| Intersection ID: 54402 | Main Street: SPRINGMAN_LN | Cross Street: LOMA_LINDA_LN | Location: SW |

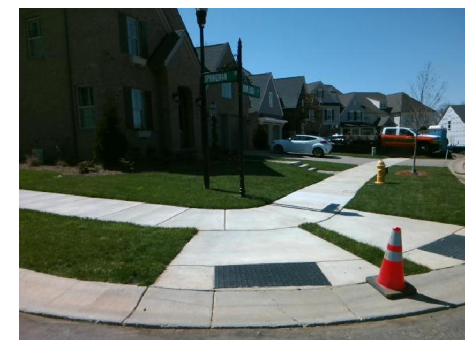
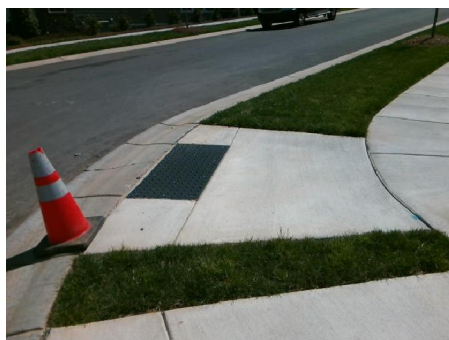
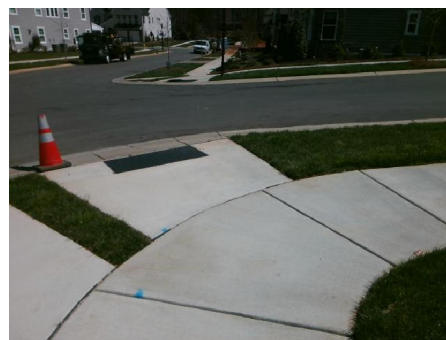
Not Found, R304.5.1, R304.5.3

| Compliance | Description | Data | Compliance | Description | Data |
|---|---|---|---|---|---|
| No | Ramp Width (in) | 47.0 | No | BlendTrans XSlope (%) | 3.5 |
| | | | No | Curb Slope (%) | 19.2 |

Remove & Replace Curb Ramp With Two New Directional Ramps or Equivalent.
