Access Compliance Report

Public Rights-of-Way

(Curb Ramps)

Intersection ID: 3925	Main Street: OAK_MANOR_LN	Cross Street: WOODFORD_BRIDGE_DR	Location: S
ADA ID: 0F672BC60895	Ramp Type: Perp	Initial Pass/Fail: Fail	Overall Compliance: No
		Severity Score: 8.75

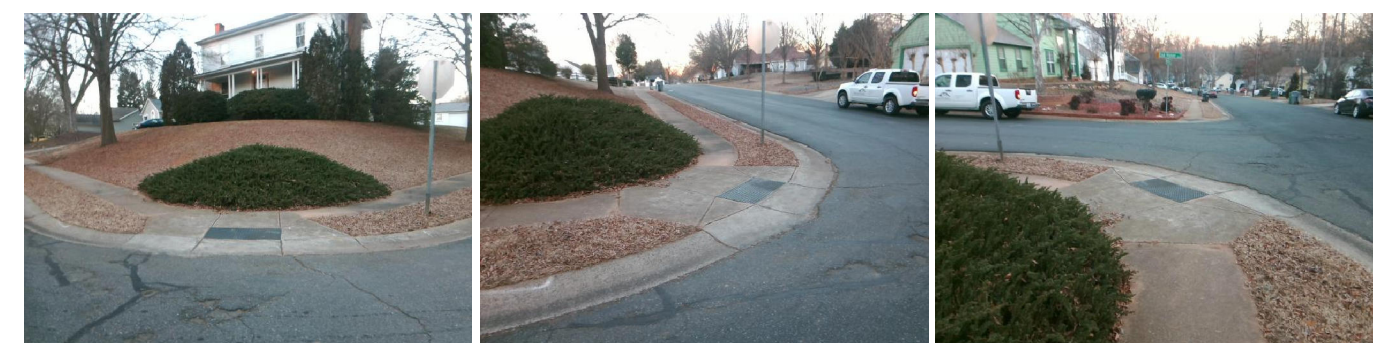
Possible Solutions:		Compliance	Description	Data
	Remove & Replace Entire Ramp.		Yes	Ramp Length (in)	90.0
			No	Ramp Width (in)	45.0
			N/A	Flare Type LT	N/A
			N/A	Flare Slope LT (%)	N/A
			N/A	Flare Traversable LT?	N/A
			N/A	Landing Length (in)	N/A
			N/A	Landing Width (in)	N/A
			N/A	Landing Slope (%)	N/A
			N/A	Landing X Slope (%)	N/A
<p>Surveyor Notes:</p> <p>N/A</p> <p>PROW/ADA:</p> <p>Not Found, R304.5.1</p>			N/A	Flare Type RT	N/A
			N/A	Flare Slope RT (%)	N/A
			N/A	Flare Traversable RT?	N/A
			N/A	DWS Provided?	N/A
			N/A	DWS Contrast?	N/A
			N/A	DWS Length (in)	N/A
			N/A	DWS Full Width?	N/A
			N/A	DWS Offset (in)	N/A
			N/A	Gutter Ponding?	N/A
			N/A	Gutter Lip Ht (in)	N/A
<p>Total Cost:</p> <p>\$ 1850.00</p>			No	Painted X Walk1?	N/A
				X Walk 1 Direction	To N
			N/A	X Walk 1 Width (in)	N/A
				X Walk 1 Slope (%)	2.8

X Walk 1 X Slope (%)	1.7
			N/A	Ramp inside XWalk1?	N/A
			N/A	Road Slope (%)	N/A
			N/A	Road X Slope (%)	N/A
			N/A	Any Obstructions?	N/A
				Obstruction Type	
			N/A	Clear Space?	N/A
			N/A	Clear Space to XWalk (in)	N/A
			N/A	Storm Grate/Utility Hazard?	N/A
				Storm Grate/Utility Type	
			N/A		N/A
			Yes	Surface Condition? (G/P)	Good
