Access Compliance Report

Public Rights-of-Way

(Curb Ramps)

Intersection ID: 14237	Main Street: BASCOM_ST	Cross Street: LABURNUM_AV	Location:	N
ADA ID: 0F9C9238A60A	Ramp Type: BlendTrans1	Initial Pass/Fail: Fail	Overall Compliance: No	Severity Score: 12.5

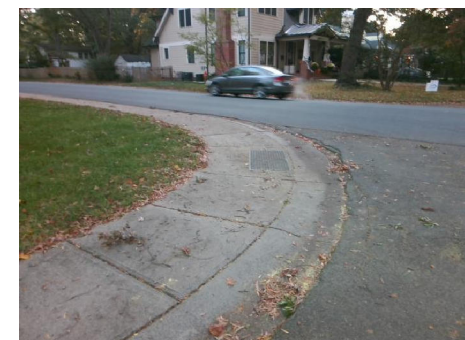
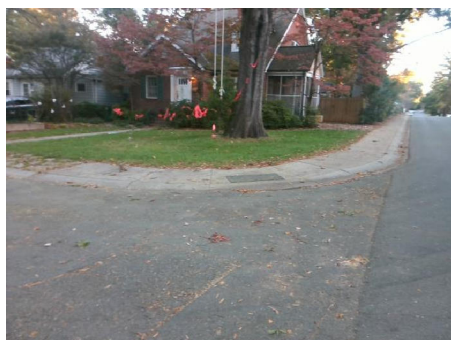
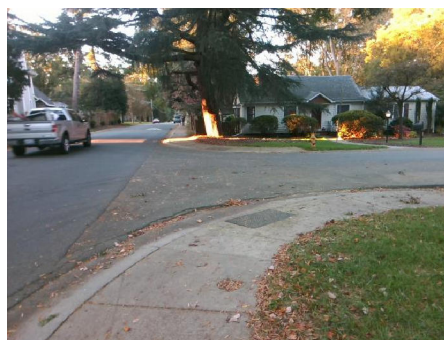
GTR GAP 9.0

Not Found, R304.5.3

Compliance	Description	Data	Compliance	Description	Data
N/A	Ramp Length (in)	61.0	Yes	BlendTrans Slope (%)	1.4
Yes	Ramp Width (in)	63.0	No	BlendTrans XSlope (%)	5.2
N/A	Flare Type LT	N/A	N/A	Flare Type RT	N/A
N/A	Flare Slope LT (%)	N/A	N/A	Flare Slope RT (%)	N/A
N/A	Flare Traversable LT?	N/A	N/A	Flare Traversable RT?	N/A
N/A	Landing Length (in)	N/A	N/A	DWS Provided?	N/A
N/A	Landing Width (in)	N/A	N/A	DWS Contrast?	N/A
N/A	Landing Slope (%)	N/A	N/A	DWS Length (in)	N/A
N/A	Landing X Slope (%)	N/A	N/A	DWS Full Width?	N/A
N/A	Landing Curb? (Y/N)	N/A	N/A	DWS Offset (in)	N/A
N/A	Shared Landing?	N/A			
N/A	Gutter Ponding?	N/A	N/A	Gutter Slope (%)	N/A
N/A	Gutter Lip Ht (in)	3.5	N/A	Gutter X Slope (%)	N/A
N/A	Painted X Walk1?	No	N/A	Painted X Walk2?	N/A
	X Walk 1 Direction	To SW		X Walk 2 Direction	N/A
	X Walk 1 Width (in)	N/A		X Walk 2 Width (in)	N/A
	X Walk 1 Slope (%)	0.9		X Walk 2 Slope (%)	N/A
	X Walk 1 X Slope (%)	2.4		X Walk 2 X Slope (%)	N/A

N/A	Ramp inside XWalk1?	N/A	N/A	Ramp inside XWalk2?	N/A
	Road Slope (%)	2.4		Clear Space?	N/A
	Road X Slope (%)	0.9	N/A	Clear Space to XWalk (in)	N/A
N/A	Any Obstructions?	N/A	N/A	Storm Grate/Utility Hazard?	N/A
	Obstruction Type			Storm Grate/Utility Type	
		N/A			N/A
			Yes	Surface Condition? (G/P)	Good
			No	Curb Slope (%)	5.8

Remove & Replace Curb Ramp With Two New Directional Ramps or Equivalent.
