# Access Compliance Report

## Public Rights-of-Way

### (Curb Ramps)

| Intersection ID: 46663 | Main Street: DONATELLO_AV | Cross Street: N_DAVIDSON_ST | Location: SW |

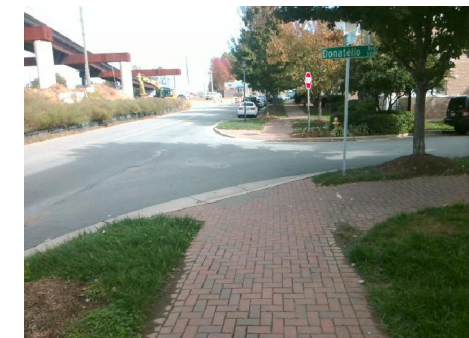
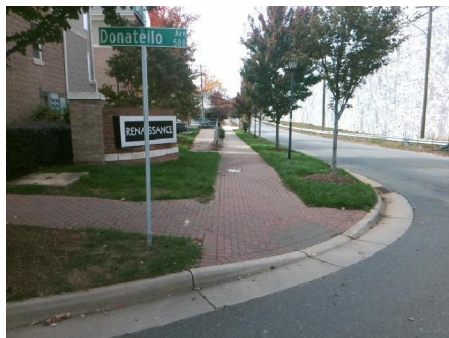
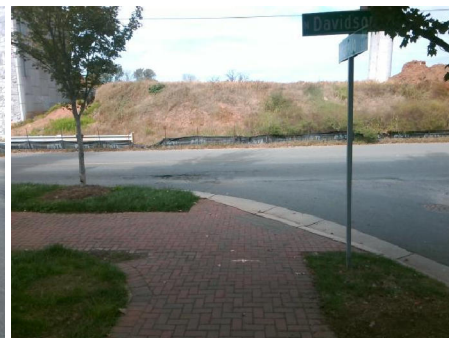
**Not Found, R304.5.1, R304.2.2, R304.5.3**

| Compliance | Description | Data | Compliance | Description | Data |
|---|---|---|---|---|---|
| N/A | Ramp Length (in) | 60.0 | No | Ramp Slope (%) | 9.9 |
| No | Ramp Width (in) | 45.0 | No | Ramp XSlope (%) | 2.3 |

**Remove & Replace Entire Ramp.**
