# Access Compliance Report

## Public Rights-of-Way

### (Curb Ramps)

Intersection ID: 12739	Main Street: N_MCDOWELL_ST	Cross Street: E_8TH_ST	Location:	W
ADA ID: 1673C4353B01	Ramp Type: Combination2Diag	Initial Pass/Fail: Fail	Overall Compliance: No	Severity Score: 0

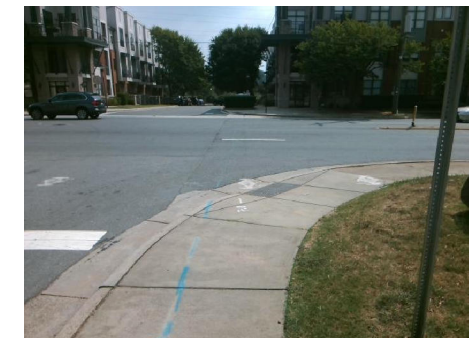
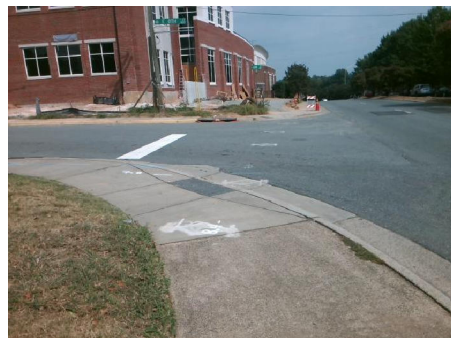
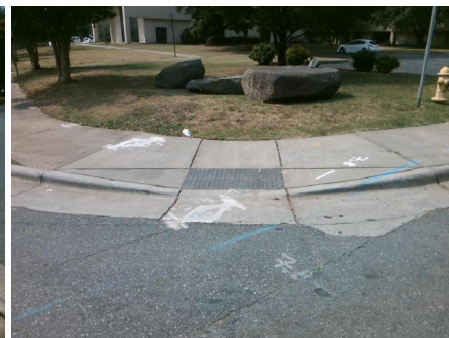
**Not Found, R304.5.3, R304.3.2**

Compliance	Description	Data	Compliance	Description	Data
N/A	Ramp Length LT (in)	N/A	N/A	Ramp Length RT (in)	53.0
N/A	Ramp Width LT (in)	N/A	Yes	Ramp Width RT (in)	51.0
N/A	Ramp Slope LT (%)	N/A	No	Ramp Slope RT (%)	9.3
N/A	Ramp XSlope LT (%)	N/A	No	Ramp XSlope RT (%)	2.6
N/A	Ramp Length (in)	25.0	Yes	Ramp Slope (%)	5.8
Yes	Ramp Width (in)	48.0	No	Ramp XSlope (%)	3.7
N/A	Flare Type LT	N/A	N/A	Flare Type RT	N/A
N/A	Flare Slope LT (%)	N/A	N/A	Flare Slope RT (%)	N/A
N/A	Flare Traversable LT?	N/A	N/A	Flare Traversable RT?	N/A
N/A	Landing Length (in)	N/A	N/A	DWS Provided?	N/A
N/A	Landing Width (in)	N/A	N/A	DWS Contrast?	N/A
N/A	Landing Slope (%)	N/A	N/A	DWS Length (in)	N/A
N/A	Landing X Slope (%)	N/A	N/A	DWS Full Width?	N/A
N/A	Landing Curb? (Y/N)	N/A	N/A	DWS Offset (in)	N/A
N/A	Shared Landing?	N/A			
N/A	Gutter Ponding?	N/A	N/A	Gutter Slope (%)	N/A
N/A	Gutter Lip Ht (in)	N/A	N/A	Gutter X Slope (%)	N/A
N/A	Painted X Walk1?	No	N/A	Painted X Walk2?	No

X Walk 1 Direction	To SE		X Walk 2 Direction	To NE
	X Walk 1 Width (in)	N/A		X Walk 2 Width (in)	N/A
	X Walk 1 Slope (%)	2.2		X Walk 2 Slope (%)	0.8
	X Walk 1 X Slope (%)	0.8		X Walk 2 X Slope (%)	2.2
N/A	Ramp inside XWalk1?	N/A	N/A	Ramp inside XWalk2?	N/A
	Road Slope (%)	4.3		Clear Space?	N/A
	Road X Slope (%)	0.3	N/A	Clear Space to XWalk (in)	N/A
			N/A	Any Obstruction?	N/A
				Obstruction Type	N/A
			N/A	Storm Grate/Utility Hazard?	N/A
				Storm Grate/Utility Type	N/A
			Yes	Surface Condition? (G/P)	Good
				Curb Slope (%)	24.9

**Remove & Replace Curb Ramp With Two New Directional Ramps or Equivalent.**
