# Access Compliance Report

## Public Rights-of-Way

### (Curb Ramps)

| Intersection ID: 25405 | Main Street: MARMOT_POINT_LN | Cross Street: PROVIDENCE_PLANTATION_LN | Location: NW |

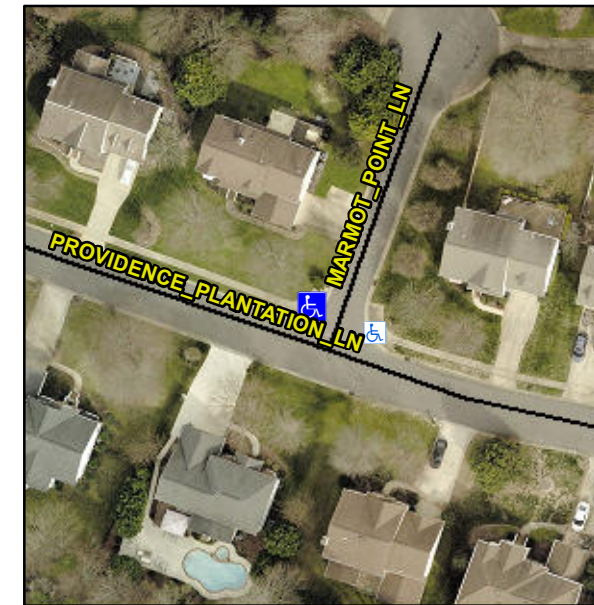
| ADA ID: 168D562C6C04 | Ramp Type: BlendTrans1 | Initial Pass/Fail: Fail | Overall Compliance: No |

**Not Found, R304.5.1, R304.5.3**

| Compliance | Description | Data | Compliance | Description | Data |
|---|---|---|---|---|---|
| No | Ramp Width (in) | 29.0 | No | BlendTrans XSlope (%) | 6.9 |

**Remove & Replace Curb Ramp With Two New Directional Ramps or Equivalent.**
