Access Compliance Report

Public Rights-of-Way

(Curb Ramps)

Intersection ID: 2555	Main Street: PELORUS_LN	Cross Street: TARBY_CT	Location:	W
ADA ID: 169BF20FB901	Ramp Type: PerpDiag	Initial Pass/Fail: Fail	Overall Compliance: No	Severity Score: 25
Codes/Mitigation Info/Possible Solution		Field Measurements/Component Compliance

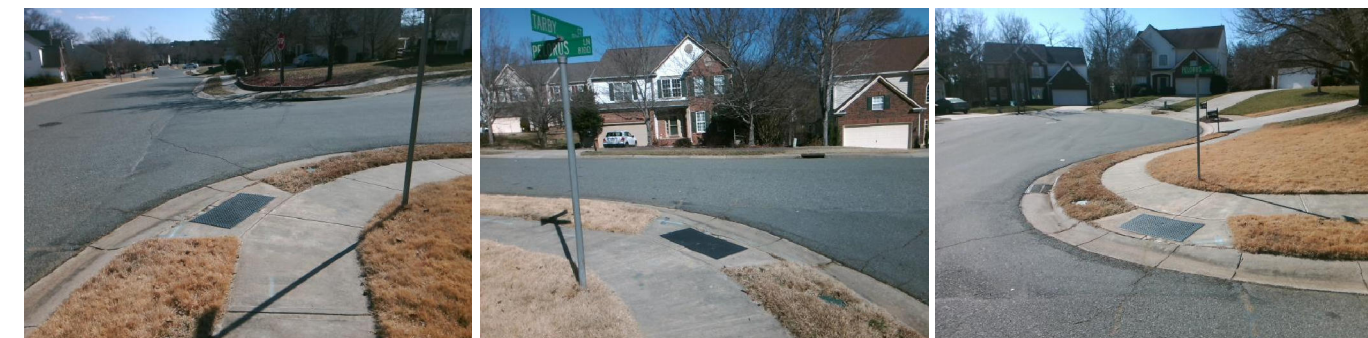
Street 1 Name **TARBY CT**
 Stop Condition-Street 2 **StopSign**
 Street 2 Name **PELORUS LN**
 Stop Condition-Street 1 **None**
