# Access Compliance Report

## Public Rights-of-Way

### (Curb Ramps)

Intersection ID: N/A	Main Street: LABEAU_AV	Cross Street: MORABLIN_DR	Location: SE
ADA ID: 16CEFD5562EC	Ramp Type: PerpDiag	Initial Pass/Fail: Fail	Overall Compliance: No
			Severity Score: 33.75

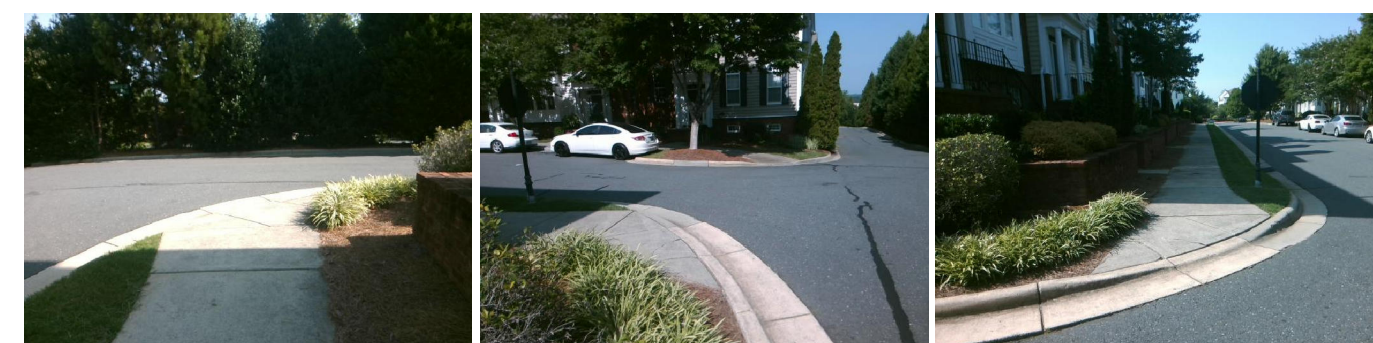
Possible Solutions:		<b>Compliance</b>	<b>Description</b>	<b>Data</b>
	<b>Remove &amp; Replace Curb Ramp With Two New Directional Ramps or Equivalent.</b>		N/A	Ramp Length (in)	52.0
			No	Ramp Width (in)	42.0
			N/A	Flare Type LT	N/A
			N/A	Flare Slope LT (%)	N/A
			N/A	Flare Traversable LT?	N/A
			N/A	Landing Length (in)	N/A
			N/A	Landing Width (in)	N/A
			N/A	Landing Slope (%)	N/A
			N/A	Landing X Slope (%)	N/A
<p>Surveyor Notes:</p> <p>N/A</p> <p>PROW/ADA:</p> <p>Not Found, R304.5.1, R304.2.2</p>			N/A	Flare Type RT	N/A
			N/A	Flare Slope RT (%)	N/A
			N/A	Flare Traversable RT?	N/A
			N/A	DWS Provided?	N/A
			N/A	DWS Contrast?	N/A
			N/A	DWS Length (in)	N/A
			N/A	DWS Full Width?	N/A
			N/A	DWS Offset (in)	N/A
			N/A	Gutter Ponding?	N/A
			N/A	Gutter Lip Ht (in)	N/A
<p>Total Cost:</p> <p>\$ 3200.00</p>			N/A	Painted X Walk1?	No

X Walk 1 Direction	To N
			N/A	X Walk 1 Width (in)	N/A
				X Walk 1 Slope (%)	2.7
				X Walk 1 X Slope (%)	3.8
			N/A	Ramp inside XWalk1?	N/A
				Road Slope (%)	1.2
				Road X Slope (%)	8.4
			N/A	Any Obstructions?	N/A
				Obstruction Type	
			N/A		N/A
			Yes	Surface Condition? (G/P)	Good
