# Access Compliance Report

## Public Rights-of-Way

### (Curb Ramps)

| Intersection ID: 15236 | Main Street: CARLING_AV | Cross Street: DILWORTH_RD_EAST | Location: E |

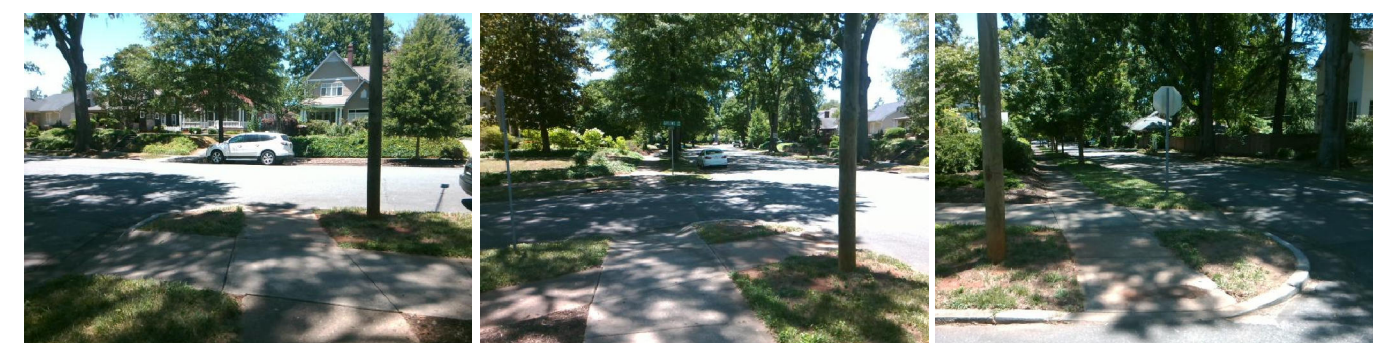
**R304.5.3, R305, R302.7.2, R304.5.4**

| Compliance | Description | Data | Compliance | Description | Data |
|---|---|---|---|---|---|
| Yes | Landing Length (in) | 50.0 | No | DWS Provided? | No |
| No | Landing X Slope (%) | 2.7 | N/A | DWS Full Width? | No |

**Remove & Replace Entire Ramp.  
Remove & Replace Gutter.**
