# Access Compliance Report

## Public Rights-of-Way

### (Curb Ramps)

Intersection ID: 45517	Main Street: BUGGY_HORSE_RD	Cross Street: MEADOW_BOTTOM_RD	Location: S
ADA ID: 18FDD3B7EB43	Ramp Type: PerpDiag	Initial Pass/Fail: Fail	Overall Compliance: No
Severity Score: 42.5			
Codes/Mitigation Info/Possible Solution		Field Measurements/Component Compliance

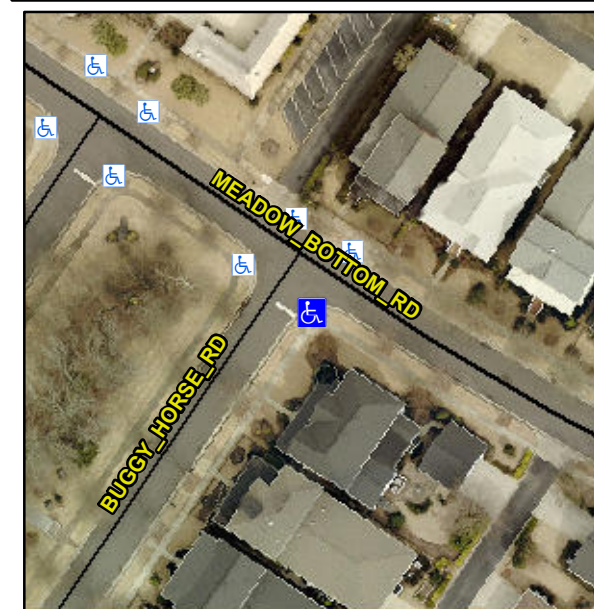
**Not Found, R304.5.1, R304.2.2**

Compliance	Description	Data	Compliance	Description	Data
N/A	Ramp Length (in)	73.0	No	Ramp Slope (%)	12.4
No	Ramp Width (in)	32.0	Yes	Ramp XSlope (%)	0.9
N/A	Flare Type LT	N/A	N/A	Flare Type RT	N/A
N/A	Flare Slope LT (%)	N/A	N/A	Flare Slope RT (%)	N/A
N/A	Flare Traversable LT?	N/A	N/A	Flare Traversable RT?	N/A
N/A	Landing Length (in)	N/A	N/A	DWS Provided?	N/A
N/A	Landing Width (in)	N/A	N/A	DWS Contrast?	N/A
N/A	Landing Slope (%)	N/A	N/A	DWS Length (in)	N/A
N/A	Landing X Slope (%)	N/A	N/A	DWS Full Width?	N/A
N/A	Landing Curb? (Y/N)	N/A	N/A	DWS Offset (in)	N/A
N/A	Shared Landing?	N/A			
N/A	Gutter Ponding?	N/A	N/A	Gutter Slope (%)	N/A
N/A	Gutter Lip Ht (in)	N/A	N/A	Gutter X Slope (%)	N/A
N/A	Painted X Walk1?	No	N/A	Painted X Walk2?	No
	X Walk 1 Direction	To NE		X Walk 2 Direction	To NW
N/A	X Walk 1 Width (in)	N/A	N/A	X Walk 2 Width (in)	N/A
	X Walk 1 Slope (%)	6.6		X Walk 2 Slope (%)	5.4
	X Walk 1 X Slope (%)	2.5		X Walk 2 X Slope (%)	3.4

N/A	Ramp inside XWalk1?	N/A	N/A	Ramp inside XWalk2?	N/A
	Road Slope (%)	0.7	N/A	Clear Space?	N/A
	Road X Slope (%)	5.9	N/A	Clear Space to XWalk (in)	N/A
N/A	Any Obstructions?	N/A	N/A	Storm Grate/Utility Hazard?	N/A
	Obstruction Type			Storm Grate/Utility Type	
		N/A			N/A
		Yes		Surface Condition? (G/P)	Good

**Remove & Replace Curb Ramp With Two New Directional Ramps or Equivalent.**
