# Access Compliance Report

## Public Rights-of-Way

### (Curb Ramps)

Intersection ID: 26242	Main Street: BAYBROOK_LN	Cross Street: BEVINGTON_PL	Location: SE
ADA ID: 1AFBAF86BB87	Ramp Type: PerpDiag	Initial Pass/Fail: Fail	Overall Compliance: No
Severity Score: 13.75			
Codes/Mitigation Info/Possible Solution		Field Measurements/Component Compliance

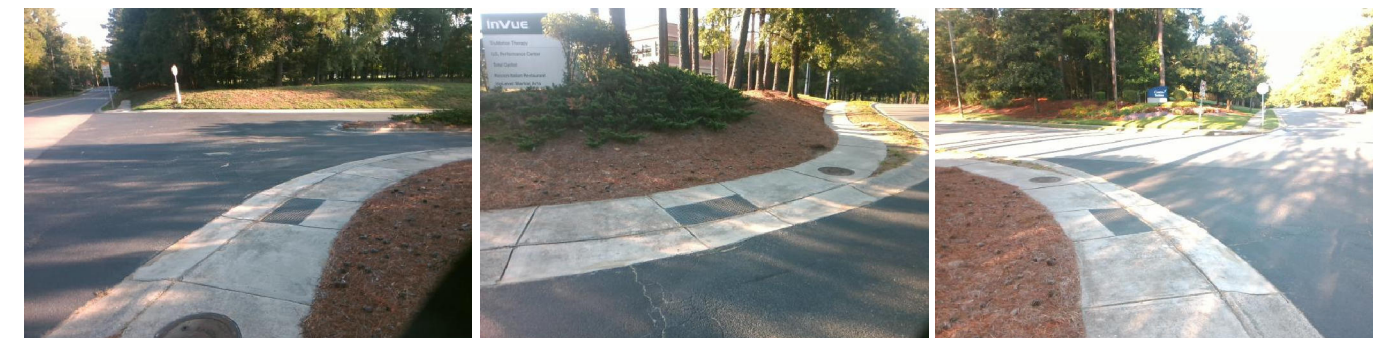
**Not Found, R304.2.2, R304.5.3**

Compliance	Description	Data	Compliance	Description	Data
N/A	Ramp Length (in)	47.5	No	Ramp Slope (%)	9.8
Yes	Ramp Width (in)	48.0	No	Ramp XSlope (%)	3.8
N/A	Flare Type LT	N/A	N/A	Flare Type RT	N/A
N/A	Flare Slope LT (%)	N/A	N/A	Flare Slope RT (%)	N/A
N/A	Flare Traversable LT?	N/A	N/A	Flare Traversable RT?	N/A
N/A	Landing Length (in)	N/A	N/A	DWS Provided?	N/A
N/A	Landing Width (in)	N/A	N/A	DWS Contrast?	N/A
N/A	Landing Slope (%)	N/A	N/A	DWS Length (in)	N/A
N/A	Landing X Slope (%)	N/A	N/A	DWS Full Width?	N/A
N/A	Landing Curb? (Y/N)	N/A	N/A	DWS Offset (in)	N/A
N/A	Shared Landing?	N/A			
N/A	Gutter Ponding?	N/A	N/A	Gutter Slope (%)	N/A
N/A	Gutter Lip Ht (in)	N/A	N/A	Gutter X Slope (%)	N/A
N/A	Painted X Walk1?	No	N/A	Painted X Walk2?	No
	X Walk 1 Direction	To NW		X Walk 2 Direction	To W
N/A	X Walk 1 Width (in)	N/A	N/A	X Walk 2 Width (in)	N/A
	X Walk 1 Slope (%)	5.7		X Walk 2 Slope (%)	1.2
	X Walk 1 X Slope (%)	0.0		X Walk 2 X Slope (%)	5.2

**Remove & Replace Curb Ramp With Two New Directional Ramps or Equivalent.**
