Access Compliance Report

Public Rights-of-Way

(Curb Ramps)

Intersection ID: 10053	Main Street: BURTON_ST	Cross Street: FONTANA_AV	Location: NW
ADA ID: 1B50E6398F64	Ramp Type: Perp	Initial Pass/Fail: Fail	Overall Compliance: No
			Severity Score: 13.75

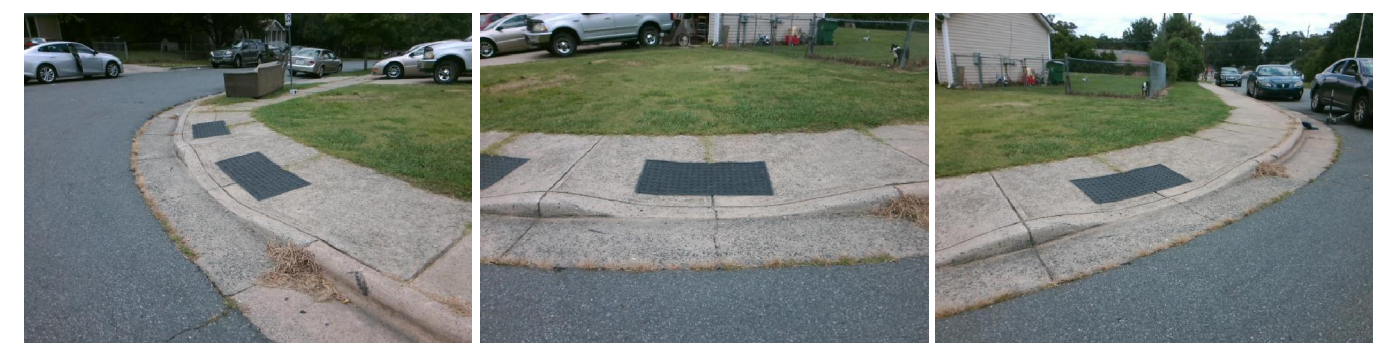
Possible Solutions:		Compliance	Description	Data
	Remove & Replace Entire Ramp.		No	Ramp Length (in)	58.5
			Yes	Ramp Width (in)	48.0
			N/A	Flare Type LT	N/A
			N/A	Flare Slope LT (%)	N/A
			N/A	Flare Traversable LT?	N/A
			N/A	Landing Length (in)	N/A
			N/A	Landing Width (in)	N/A
			N/A	Landing Slope (%)	N/A
			N/A	Landing X Slope (%)	N/A
<p>Surveyor Notes:</p> <p>N/A</p> <p>PROW/ADA:</p> <p>Not Found, R304.2.2, R304.5.3</p>			N/A	Flare Type RT	N/A
			N/A	Flare Slope RT (%)	N/A
			N/A	Flare Traversable RT?	N/A
			N/A	DWS Provided?	N/A
			N/A	DWS Contrast?	N/A
			N/A	DWS Length (in)	N/A
			N/A	DWS Full Width?	N/A
			N/A	DWS Offset (in)	N/A
			N/A	Gutter Ponding?	N/A
			N/A	Gutter Lip Ht (in)	1.0
			No	Painted X Walk1?	N/A
				X Walk 1 Direction	To SE
			N/A	X Walk 1 Width (in)	N/A
				X Walk 1 Slope (%)	3.6
				X Walk 1 X Slope (%)	0.7

N/A	Ramp inside XWalk1?	N/A
			N/A	Road Slope (%)	N/A
			N/A	Road X Slope (%)	N/A
			N/A	Any Obstructions?	N/A
				Obstruction Type	
Total Cost:					
		\$ 1850.00			
			N/A		N/A
			Yes	Surface Condition? (G/P)	Good
