Access Compliance Report

Public Rights-of-Way

Intersection ID: 18557	Main Street: MILFORD_RD	Cross Street: SENECA_PL	Location: SE
ADA ID: 1CAB68C7880E	Ramp Type: PerpDiag	Initial Pass/Fail: Fail	Overall Compliance: No
Severity Score: 33.75			
Codes/Mitigation Info/Possible Solution		Field Measurements/Component Compliance

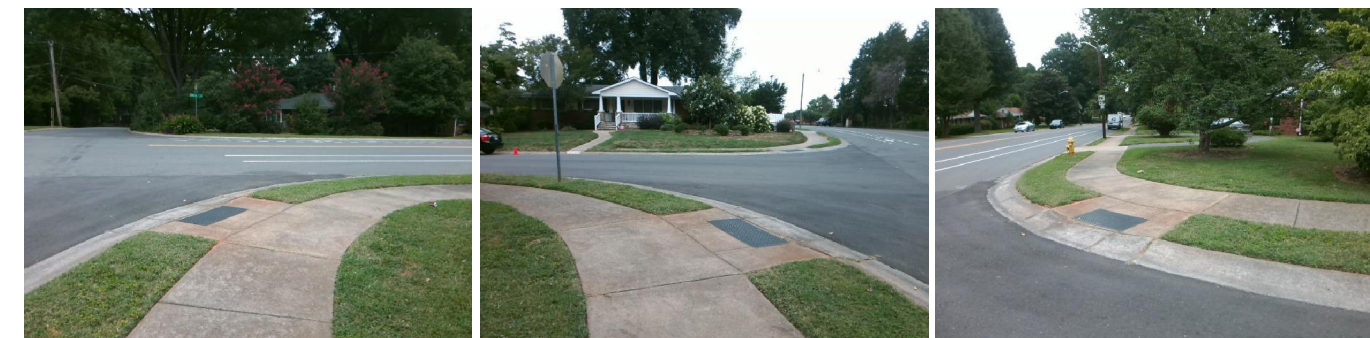
Not Found, R304.5.1, R304.5.3

Compliance	Description	Data	Compliance	Description	Data
N/A	Ramp Length (in)	108.0	Yes	Ramp Slope (%)	5.5
No	Ramp Width (in)	44.0	No	Ramp XSlope (%)	7.2
N/A	Flare Type LT	N/A	N/A	Flare Type RT	N/A
N/A	Flare Slope LT (%)	N/A	N/A	Flare Slope RT (%)	N/A
N/A	Flare Traversable LT?	N/A	N/A	Flare Traversable RT?	N/A
N/A	Landing Length (in)	N/A	N/A	DWS Provided?	N/A
N/A	Landing Width (in)	N/A	N/A	DWS Contrast?	N/A
N/A	Landing Slope (%)	N/A	N/A	DWS Length (in)	N/A
N/A	Landing X Slope (%)	N/A	N/A	DWS Full Width?	N/A
N/A	Landing Curb? (Y/N)	N/A	N/A	DWS Offset (in)	N/A
N/A	Shared Landing?	N/A			
N/A	Gutter Ponding?	N/A	N/A	Gutter Slope (%)	N/A
N/A	Gutter Lip Ht (in)	N/A	N/A	Gutter X Slope (%)	N/A
N/A	Painted X Walk1?	No	N/A	Painted X Walk2?	No
	X Walk 1 Direction	To NE		X Walk 2 Direction	To NW
N/A	X Walk 1 Width (in)	N/A	N/A	X Walk 2 Width (in)	N/A
	X Walk 1 Slope (%)	1.1		X Walk 2 Slope (%)	3.9
	X Walk 1 X Slope (%)	4.5		X Walk 2 X Slope (%)	0.5

Remove & Replace Curb Ramp With Two New Directional Ramps or Equivalent.
