# Access Compliance Report

## Public Rights-of-Way

### (Curb Ramps)

Intersection ID: 23880	Main Street: CHINA GROVE CHURCH RD	Cross Street: STERLING LN	Location:	NW
ADA ID: 1DC77E1EC5BF	Ramp Type: PerpDiag	Initial Pass/Fail: Fail	Overall Compliance: No	Severity Score: 35
Codes/Mitigation Info/Possible Solution		Field Measurements/Component Compliance

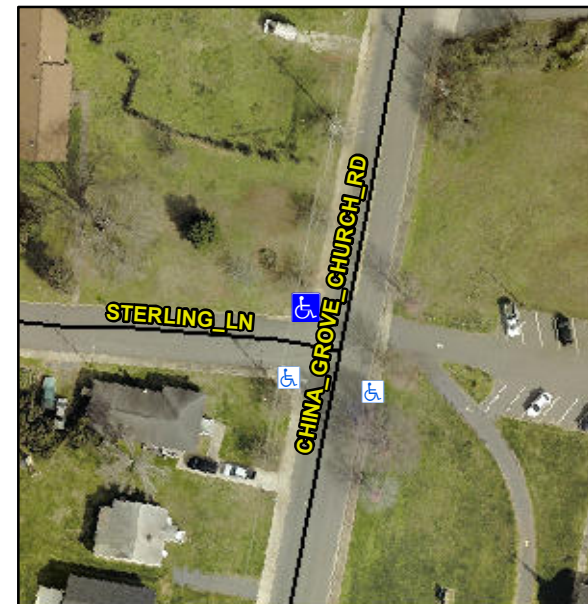
**Not Found, R304.5.1, R304.2.2, R304.5.3**

Compliance	Description	Data	Compliance	Description	Data
N/A	Ramp Length (in)	48.0	No	Ramp Slope (%)	14.4
No	Ramp Width (in)	46.0	No	Ramp XSlope (%)	4.9
N/A	Flare Type LT	N/A	N/A	Flare Type RT	N/A
N/A	Flare Slope LT (%)	N/A	N/A	Flare Slope RT (%)	N/A
N/A	Flare Traversable LT?	N/A	N/A	Flare Traversable RT?	N/A
N/A	Landing Length (in)	N/A	N/A	DWS Provided?	N/A
N/A	Landing Width (in)	N/A	N/A	DWS Contrast?	N/A
N/A	Landing Slope (%)	N/A	N/A	DWS Length (in)	N/A
N/A	Landing X Slope (%)	N/A	N/A	DWS Full Width?	N/A
N/A	Landing Curb? (Y/N)	N/A	N/A	DWS Offset (in)	N/A
N/A	Shared Landing?	N/A			
N/A	Gutter Ponding?	N/A	N/A	Gutter Slope (%)	N/A
N/A	Gutter Lip Ht (in)	N/A	N/A	Gutter X Slope (%)	N/A
N/A	Painted X Walk1?	No	N/A	Painted X Walk2?	No
	X Walk 1 Direction	To SW		X Walk 2 Direction	To SE
N/A	X Walk 1 Width (in)	N/A	N/A	X Walk 2 Width (in)	N/A
	X Walk 1 Slope (%)	0.6		X Walk 2 Slope (%)	1.0
	X Walk 1 X Slope (%)	7.0		X Walk 2 X Slope (%)	0.9

**Remove & Replace Curb Ramp With Two New Directional Ramps or Equivalent.**
