# Access Compliance Report

## Public Rights-of-Way

### (Curb Ramps)

Intersection ID: 53962	Main Street: LILAC_TREE_AV	Cross Street: DENBUR_DR	Location: W
ADA ID: 20F0C4508813	Ramp Type: Perp	Initial Pass/Fail: Pass	Overall Compliance: No
Severity Score: 0.25			
Codes/Mitigation Info/Possible Solution		Field Measurements/Component Compliance

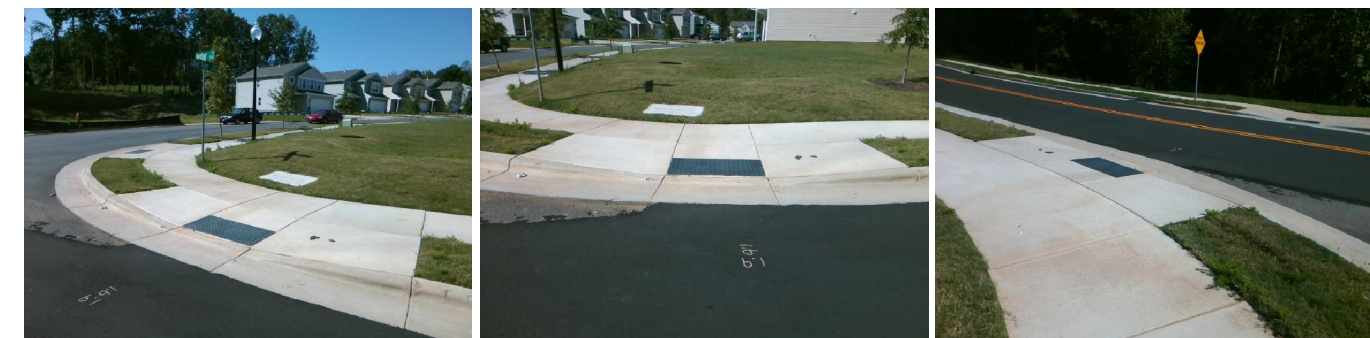
**Not Found, R304.5.3**

Compliance	Description	Data	Compliance	Description	Data
N/A	Ramp Length (in)	50.0	Yes	Ramp Slope (%)	6.6
Yes	Ramp Width (in)	48.0	No	Ramp XSlope (%)	2.1
N/A	Flare Type LT	Sloped	N/A	Flare Type RT	N/A
N/A	Flare Slope LT (%)	5.2	N/A	Flare Slope RT (%)	6.9
N/A	Flare Traversable LT?	No	N/A	Flare Traversable RT?	No
Yes	Landing Length (in)	59.5	Yes	DWS Provided?	Yes
Yes	Landing Width (in)	48.0	Yes	DWS Contrast?	Yes
Yes	Landing Slope (%)	1.2	Yes	DWS Length (in)	24.0
No	Landing X Slope (%)	2.6	Yes	DWS Full Width?	Yes
N/A	Landing Curb? (Y/N)	No	Yes	DWS Offset (in)	2.0
N/A	Shared Landing?	Yes			
Yes	Gutter Ponding?	No	Yes	Gutter Slope (%)	2.3
Yes	Gutter Lip Ht (in)	0.0	Yes	Gutter X Slope (%)	1.1
N/A	Painted X Walk1?	No	N/A	Painted X Walk2?	N/A
	X Walk 1 Direction	To NE		X Walk 2 Direction	N/A
N/A	X Walk 1 Width (in)	N/A	N/A	X Walk 2 Width (in)	N/A
	X Walk 1 Slope (%)	1.6		X Walk 2 Slope (%)	N/A
	X Walk 1 X Slope (%)	1.9		X Walk 2 X Slope (%)	N/A

**Remove & Replace Entire Ramp.**
