Access Compliance Report

Public Rights-of-Way

(Curb Ramps)

Intersection ID: 11799	Main Street: MECKLENBURG_AV	Cross Street: NORCROSS_PL	Location: SW
ADA ID: 22C6E9608D2D	Ramp Type: Directional1	Initial Pass/Fail: Fail	Overall Compliance: No
			Severity Score: 13.75

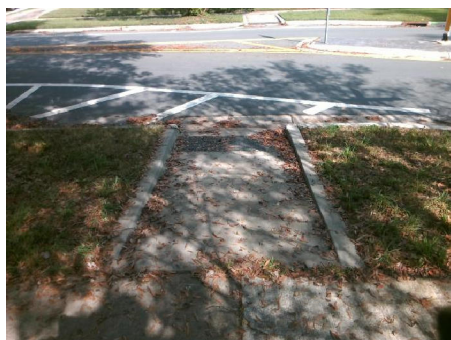
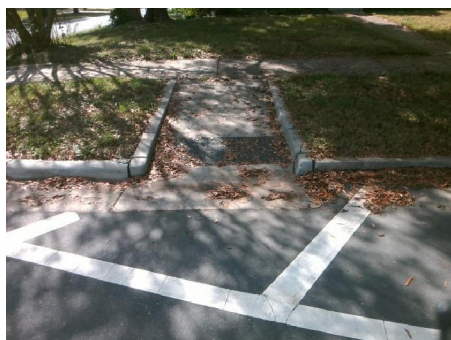
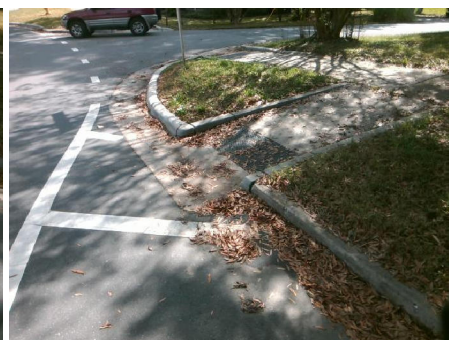
PROW/ADA:			N/A	Landing Curb? (Y/N)	N/A	N/A	DWS Offset LT (in)	N/A
R304.2.2, R304.5.3			N/A	Shared Landing?	N/A	N/A	DWS Offset RT (in)	N/A
			N/A	Gutter Ponding?	0.0	N/A	Gutter Slope (%)	N/A
			N/A	Gutter Lip Ht (in)	0.0	N/A	Gutter X Slope (%)	N/A
			N/A	Painted X Walk1?	No		Road Slope (%)	3.6
				X Walk 1 Direction	To N		Road X Slope (%)	3.0
				X Walk 1 Width (in)	N/A		Clear Space?	N/A
				X Walk 1 Slope (%)	3.6	N/A	Clear Space to XWalk (in)	N/A
				X Walk 1 X Slope (%)	3.0	N/A	Storm Grate/Utility Hazard?	N/A
			N/A	Ramp inside XWalk1?	N/A		Storm Grate/Utility Type	
			N/A	Any Obstructions?	N/A			N/A
				Obstruction Type		Yes	Surface Condition? (G/P)	Good
						N/A	Curb Slope (%)	7.6
Total Cost:		\$ 1600.00

<div>Street 1 Name<div>MECKLENBURG AV</div></div> <div>Stop Condition-Street 1<div>None</div></div> <div>Street 2 Name<div>N/A</div></div> <div>Stop Condition-Street 2<div>N/A</div></div>	Possible Solutions:		Compliance			Compliance		
	Remove & Replace Entire Ramp.		N/A	Ramp Length (in)	109.0	N/A	Grade Break?	N/A
			Yes	Ramp Width (in)	59.0	N/A	Grade Break Slope (%)	0.0
			No	Ramp Slope (%)	8.7	N/A	Grade Break XSlope (%)	0.0
			No	Ramp XSlope (%)	3.4			
			N/A	Flare Type LT	N/A	N/A	Flare Type RT	N/A
			N/A	Flare Slope LT (%)	N/A	N/A	Flare Slope RT (%)	0.0
			N/A	Flare Traversable LT?	N/A	N/A	Flare Traversable RT?	N/A
	Surveyor Notes:		N/A	Landing Length (in)	0.0	N/A	DWS Provided?	N/A
				N/A	Landing Width (in)	0.0	N/A	DWS Contrast?
			N/A	Landing Slope (%)	0.0	N/A	DWS Length (in)	N/A
			N/A	Landing X Slope (%)	0.0	N/A	DWS Full Width?	N/A
