# Access Compliance Report

## Public Rights-of-Way

### (Curb Ramps)

| Intersection ID: 53380 | Main Street: IKEA_BV | Cross Street: LEWIS_ST | Location: E |

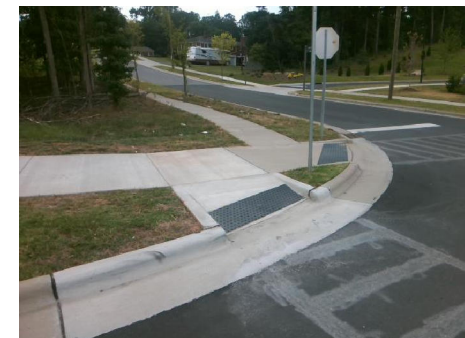
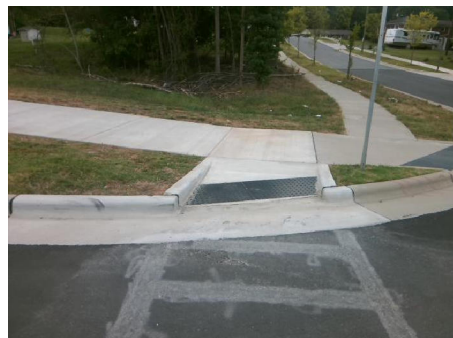
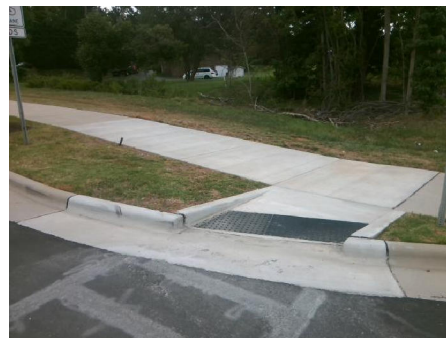
**Not Found, R305.2, R302.7**

| Compliance | Description | Data | Compliance | Description | Data |
|---|---|---|---|---|---|
| N/A | Landing Curb? (Y/N) | No | No | DWS Offset (in) | 3.3 |
| | | | No | Curb Slope (%) | 10.0 |

**Remove & Replace Curb Ramp With Two New Directional Ramps or Equivalent.**
