# Access Compliance Report

## Public Rights-of-Way

### (Curb Ramps)

Intersection ID: 10038458	Main Street: SOUTHERN_PINE_BV	Cross Street: N/A	Location: S
ADA ID: 2438160C8C52	Ramp Type: PerpDiag	Initial Pass/Fail: Fail	Overall Compliance: No
Severity Score: 37.5			
Codes/Mitigation Info/Possible Solution		Field Measurements/Component Compliance

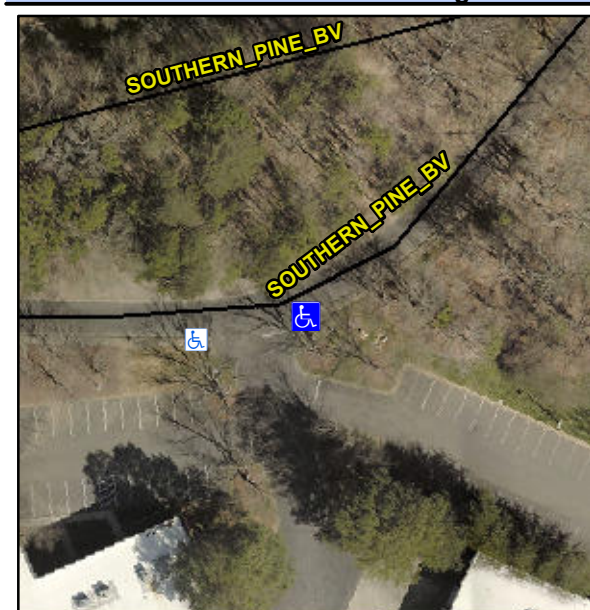
**Not Found, R304.2.2, R304.5.3**

Compliance	Description	Data	Compliance	Description	Data
N/A	Ramp Length (in)	48.0	No	Ramp Slope (%)	9.3
Yes	Ramp Width (in)	48.0	No	Ramp XSlope (%)	7.6
N/A	Flare Type LT	N/A	N/A	Flare Type RT	N/A
N/A	Flare Slope LT (%)	N/A	N/A	Flare Slope RT (%)	N/A
N/A	Flare Traversable LT?	N/A	N/A	Flare Traversable RT?	N/A
N/A	Landing Length (in)	N/A	N/A	DWS Provided?	N/A
N/A	Landing Width (in)	N/A	N/A	DWS Contrast?	N/A
N/A	Landing Slope (%)	N/A	N/A	DWS Length (in)	N/A
N/A	Landing X Slope (%)	N/A	N/A	DWS Full Width?	N/A
N/A	Landing Curb? (Y/N)	N/A	N/A	DWS Offset (in)	N/A
N/A	Shared Landing?	N/A			
N/A	Gutter Ponding?	N/A	N/A	Gutter Slope (%)	N/A
N/A	Gutter Lip Ht (in)	N/A	N/A	Gutter X Slope (%)	N/A
N/A	Painted X Walk1?	No	N/A	Painted X Walk2?	No
	X Walk 1 Direction	To N		X Walk 2 Direction	To W
N/A	X Walk 1 Width (in)	N/A	N/A	X Walk 2 Width (in)	N/A
	X Walk 1 Slope (%)	1.6		X Walk 2 Slope (%)	6.4
	X Walk 1 X Slope (%)	5.4		X Walk 2 X Slope (%)	6.2

N/A	Ramp inside XWalk1?	N/A	N/A	Ramp inside XWalk2?	N/A
	Road Slope (%)	5.7	N/A	Clear Space?	N/A
	Road X Slope (%)	2.5	N/A	Clear Space to XWalk (in)	N/A
N/A	Any Obstructions?	N/A	N/A	Storm Grate/Utility Hazard?	N/A
	Obstruction Type			Storm Grate/Utility Type	
		N/A			N/A
			Yes	Surface Condition? (G/P)	Good

**Remove & Replace Curb Ramp With Two New Directional Ramps or Equivalent.**
