Intersection ID: 42983	Main Street: CHRUDAN_DR	Cross Street: LADORA_DR	Location:	E
ADA ID: 24CB2A6110C1	Ramp Type: PerpDiag	Initial Pass/Fail: Fail	Overall Compliance: No	Severity Score: 46.25

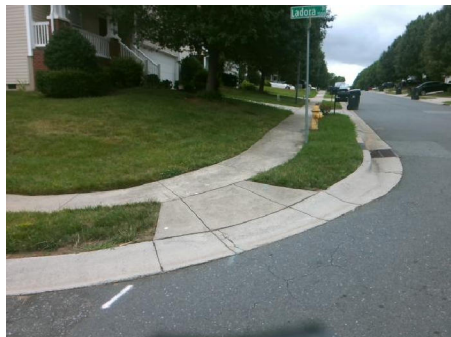
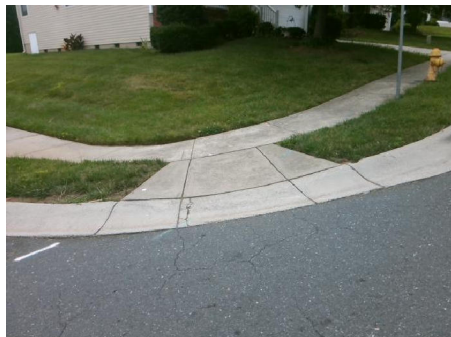
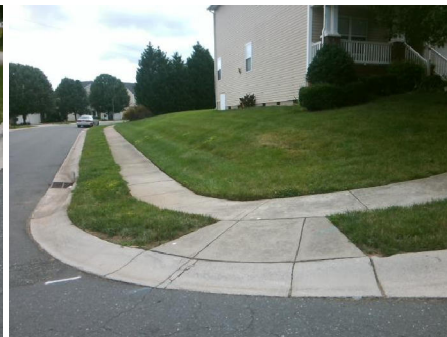
**Not Found, R304.5.1, R304.2.2,
R304.5.3**

Possible Solutions:		Compliance	Description	Data	Compliance	Description	Data
Remove & Replace Curb Ramp With Two New Directional Ramps or Equivalent.	N/A	Ramp Length (in)	46.5	No	Ramp Slope (%)	11.1	
	No	Ramp Width (in)	37.0	No	Ramp XSlope (%)	14.0	
	N/A	Flare Type LT	N/A	N/A	Flare Type RT	N/A	
	N/A	Flare Slope LT (%)	N/A	N/A	Flare Slope RT (%)	N/A	
	N/A	Flare Traversable LT?	N/A	N/A	Flare Traversable RT?	N/A	
	N/A	Landing Length (in)	N/A	N/A	DWS Provided?	N/A	
	N/A	Landing Width (in)	N/A	N/A	DWS Contrast?	N/A	
	N/A	Landing Slope (%)	N/A	N/A	DWS Length (in)	N/A	
	N/A	Landing X Slope (%)	N/A	N/A	DWS Full Width?	N/A	
	N/A	Landing Curb? (Y/N)	N/A	N/A	DWS Offset (in)	N/A	
Surveyor Notes: N/A	N/A	Shared Landing?	N/A				
	N/A	Gutter Ponding?	N/A	N/A	Gutter Slope (%)	N/A	
	N/A	Gutter Lip Ht (in)	N/A	N/A	Gutter X Slope (%)	N/A	
	N/A	Painted X Walk1?	No	N/A	Painted X Walk2?	No	
		X Walk 1 Direction	To NW		X Walk 2 Direction	To SW

N/A	X Walk 1 Width (in)	N/A	N/A	X Walk 2 Width (in)	N/A	
		X Walk 1 Slope (%)	5.4		X Walk 2 Slope (%)	3.0	
		X Walk 1 X Slope (%)	8.8		X Walk 2 X Slope (%)	9.1	
	N/A	Ramp inside XWalk1?	N/A	N/A	Ramp inside XWalk2?	N/A	
		Road Slope (%)	9.7	N/A	Clear Space?	N/A	
PROW/ADA: Not Found, R304.5.1, R304.2.2, R304.5.3		Road X Slope (%)	1.4	N/A	Clear Space to XWalk (in)	N/A	
	N/A	Any Obstructions?	N/A	N/A	Storm Grate/Utility Hazard?	N/A	
		Obstruction Type			Storm Grate/Utility Type		
			N/A			N/A	
				Yes	Surface Condition? (G/P)	Good	
	Total Cost:	\$	3200.00

Remove & Replace Curb Ramp With Two New Directional Ramps or Equivalent.
