Access Compliance Report

Public Rights-of-Way

(Curb Ramps)

Intersection ID: 52127	Main Street: VALLEYDALE_RD	Cross Street: FRED_D_ALEXANDER_BV	Location: E
ADA ID: 26D249D4505D	Ramp Type: Combination1	Initial Pass/Fail: Fail	Overall Compliance: No
		Severity Score: 12.5

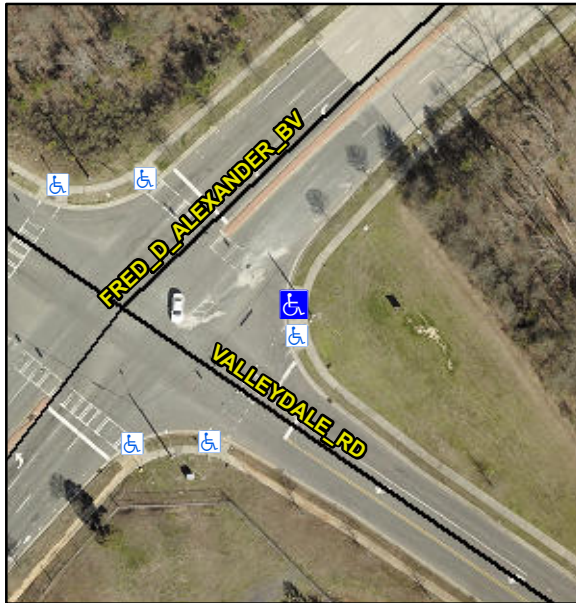
RP & LT RP < 5%

Not Found, R304.3.2

Compliance	Description	Data	Compliance	Description	Data
N/A	Ramp Length LT (in)	61.0	N/A	Ramp Length RT (in)	63.0
Yes	Ramp Width LT (in)	60.0	Yes	Ramp Width RT (in)	60.0
Yes	Ramp Slope LT (%)	3.2	No	Ramp Slope RT (%)	9.0
Yes	Ramp XSlope LT (%)	1.6	Yes	Ramp XSlope RT (%)	1.5
N/A	Ramp Length (in)	64.0	Yes	Ramp Slope (%)	2.1
Yes	Ramp Width (in)	57.0	Yes	Ramp XSlope (%)	0.3
N/A	Flare Type LT	N/A	N/A	Flare Type RT	N/A
N/A	Flare Slope LT (%)	N/A	N/A	Flare Slope RT (%)	N/A
N/A	Flare Traversable LT?	N/A	N/A	Flare Traversable RT?	N/A
N/A	Landing Length (in)	N/A	N/A	DWS Provided?	N/A
N/A	Landing Width (in)	N/A	N/A	DWS Contrast?	N/A
N/A	Landing Slope (%)	N/A	N/A	DWS Length (in)	N/A
N/A	Landing X Slope (%)	N/A	N/A	DWS Full Width?	N/A
N/A	Landing Curb? (Y/N)	N/A	N/A	DWS Offset (in)	N/A
N/A	Shared Landing?	N/A			
N/A	Gutter Ponding?	N/A	N/A	Gutter Slope (%)	N/A
N/A	Gutter Lip Ht (in)	N/A	N/A	Gutter X Slope (%)	N/A
N/A	Painted X Walk1?	Yes	N/A	Painted X Walk2?	N/A

Remove & Replace Entire Ramp.
