Access Compliance Report

Public Rights-of-Way

| Intersection ID: 10559 | Main Street: CHARLES_AV | Cross Street: E_35TH_ST | Location: E |
| ADA ID: 2A2E39EEABA6 | Ramp Type: Perp | Initial Pass/Fail: Fail | Overall Compliance: No |

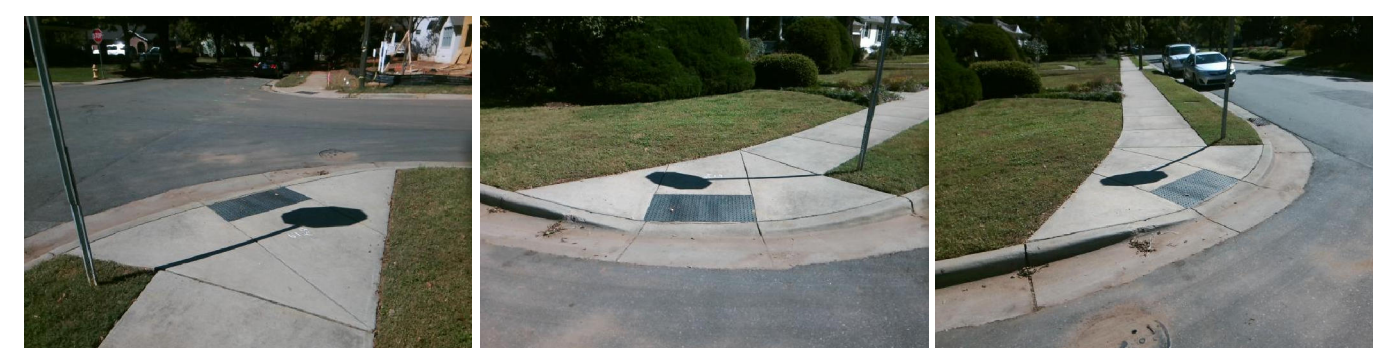
| Codes/Mitigation Info/Possible Solution | | | Field Measurements/Component Compliance | | |
|---|--|---|---|---|---|
| | Remove & Replace Entire Ramp. | | No | Ramp Length (in) | 71.5 |
| | | | No | Ramp Width (in) | 46.0 |
| <p>Surveyor Notes:</p> <p>N/A</p> <p>PROW/ADA:</p> <p>Not Found, R304.5.1, R304.2.2</p> | | | N/A | Flare Type RT | N/A |
